Bridle Estates Home Owners' Association
Fence Inspection
And
Maintenance Recommendations
April 14, 2025

April 14, 2025
Barry Manovich
Max Lewin
Randy Parsons
Bruce Sorge
Dwayne Thomas
Byron Turner

Summary

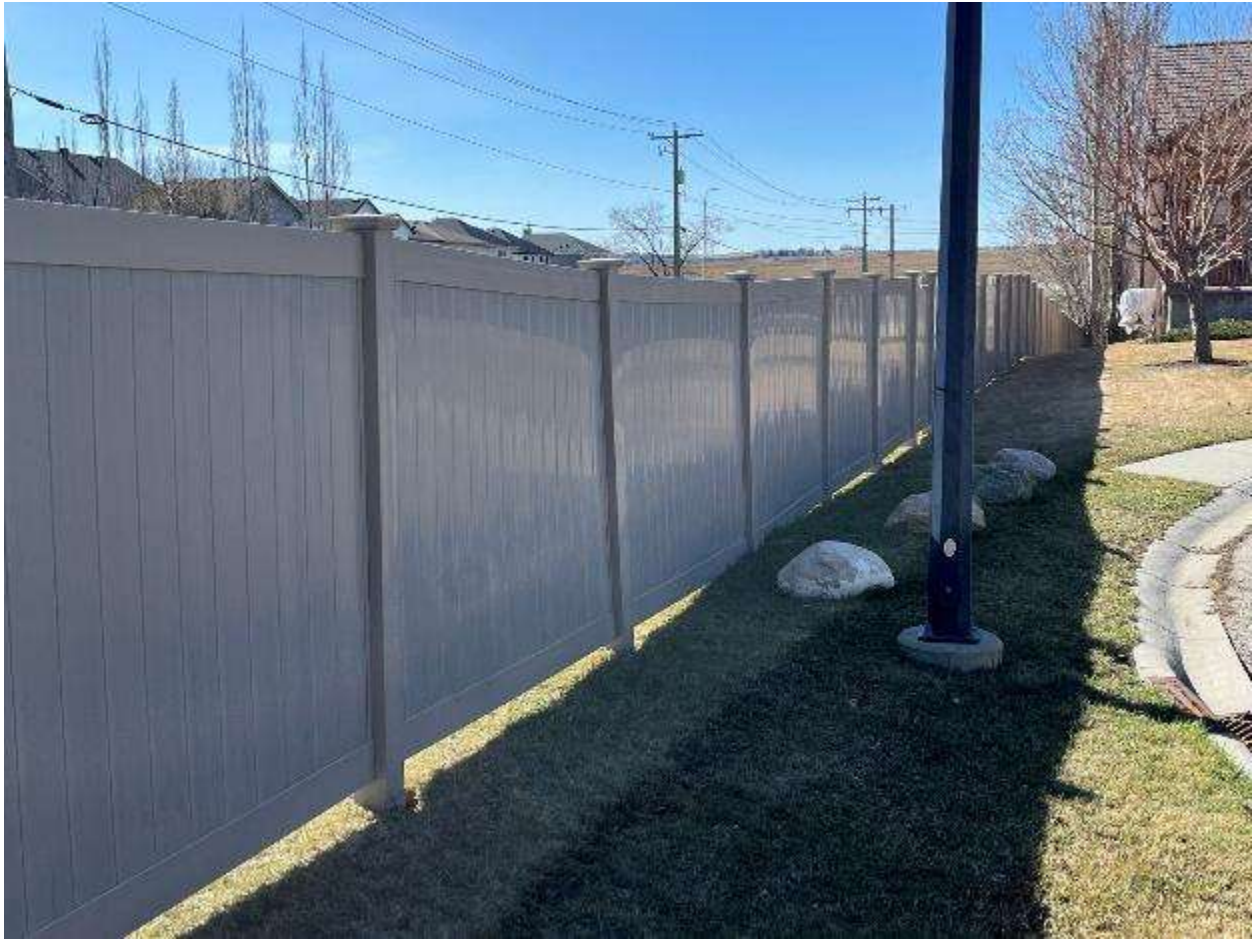
Figure 1 Vinyl fence along 24st, note the air gap at the bottom rail and the structural integrity of the fence

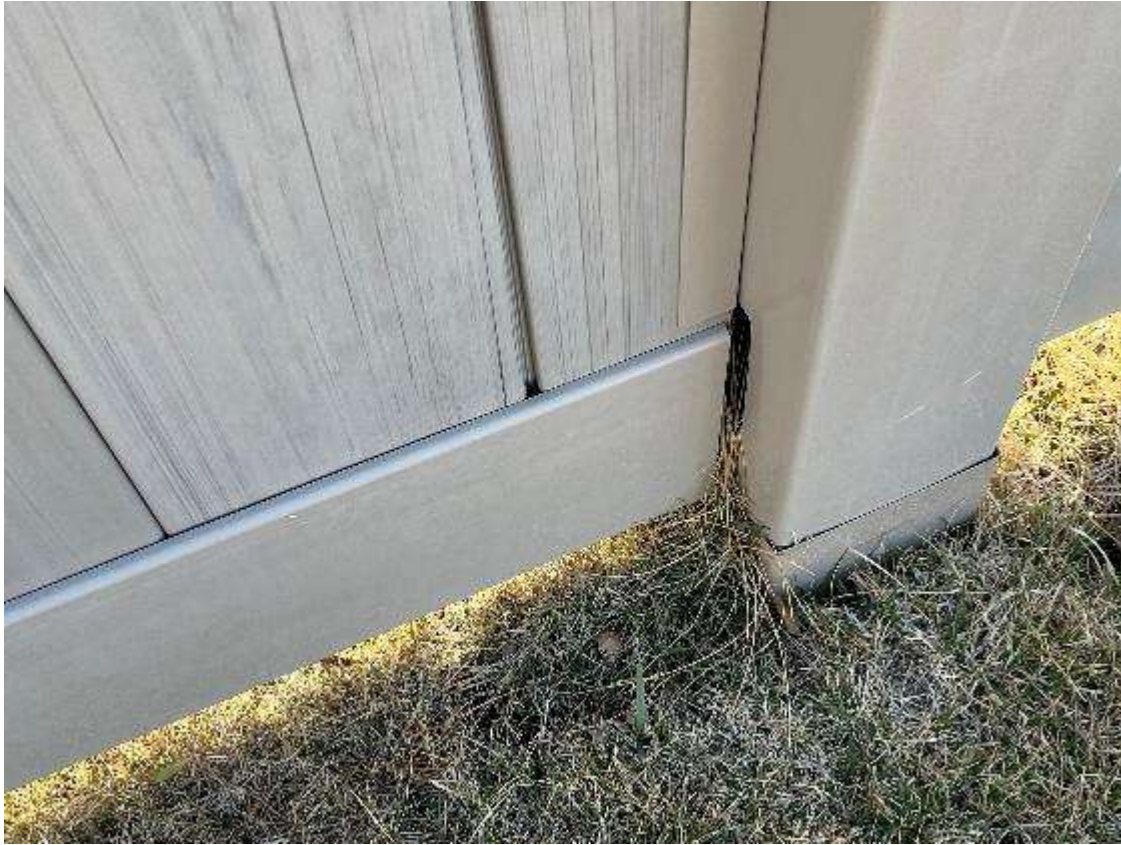
Figure 2 Vinyl fence with bottom rail adrift of the post, and easy fix to simply position it back in the post

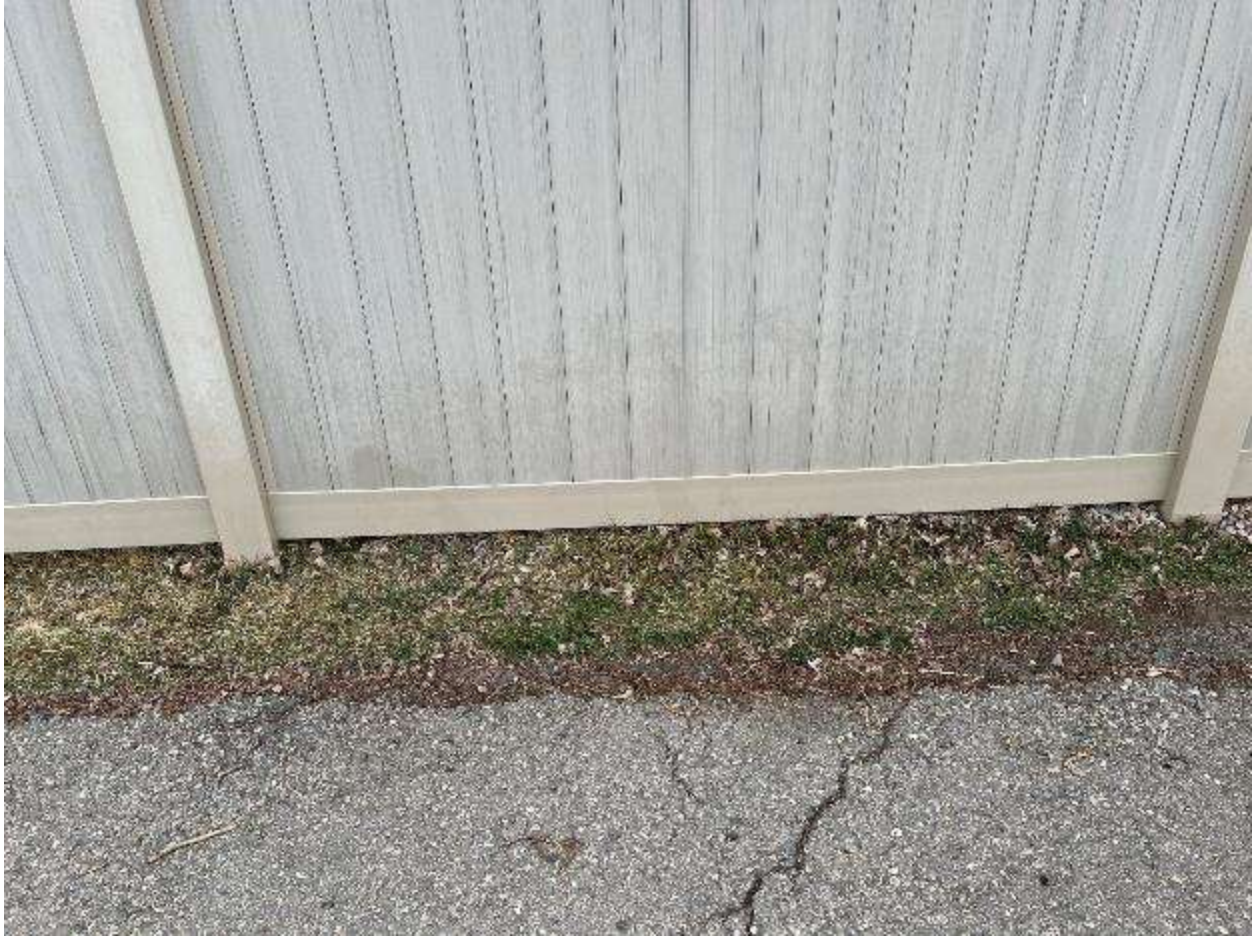
- There is considerable spotting along the lower fence panels on the section of fence along 24th St north of Bridle Estates Rd. Winter snow clearing by a blower deposits debris on the lower part of the panels staining the surface. This section is also frequented by dogs who pass on their scent.

Figure 3 Vinyl fence along 24 St showing staining mainly due to snow removal with a blower piling snow against the fence.

1. Home owners should be reminded to avoid piling material against the vinyl fence. Some owners may have to be approached by the board.
2. The section north of Bridle Estates Rd along 24th Street (Bridle Estates Road north to condo fence corner) requires washing with a cleaner, some experimenting will need to be done.
3. The snow clearing service provider for this section of sidewalk should be advised to refrain from the practise of directing snow toward the fence.

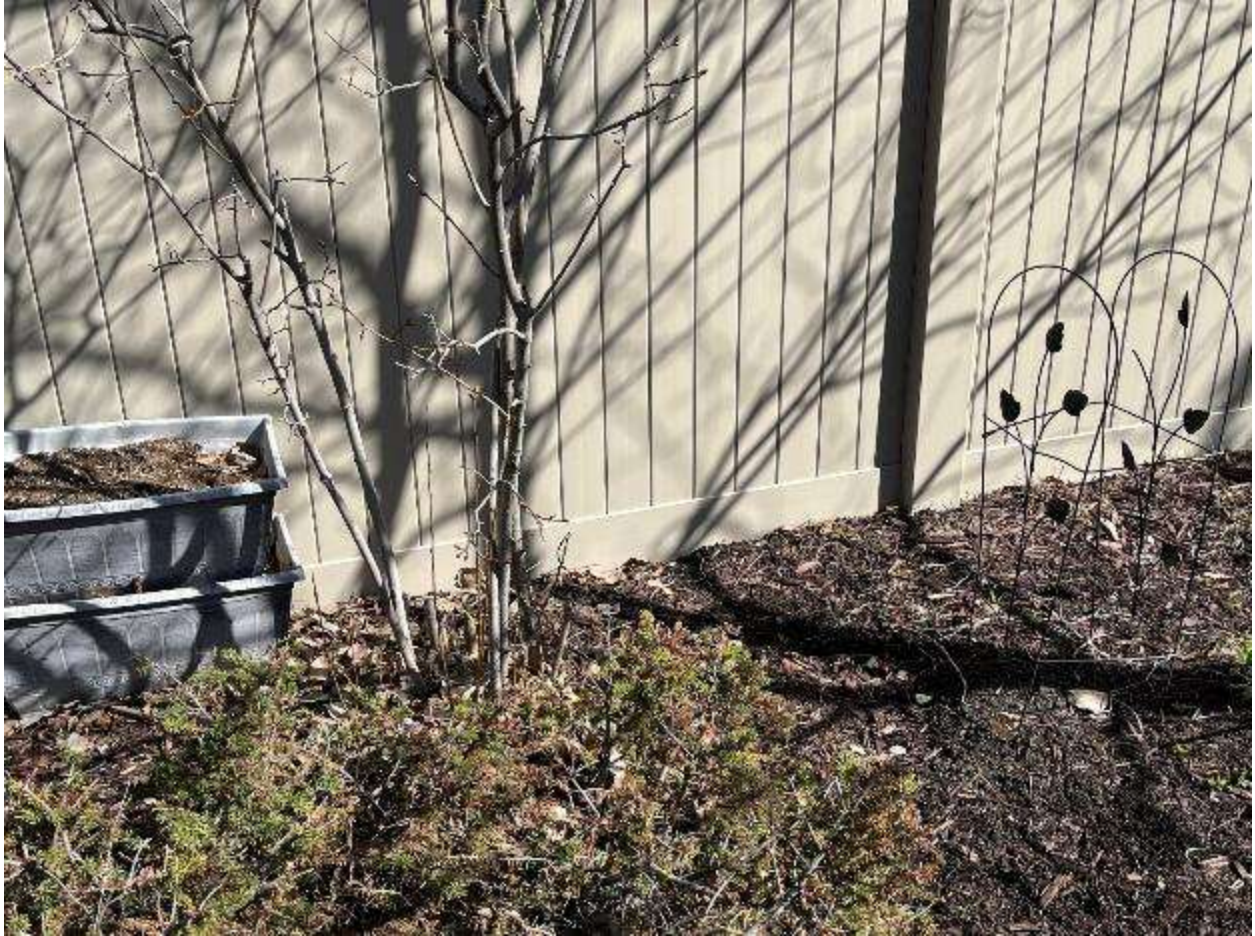
- The Vinyl Fence is structurally very sound. There are minor scruff marks and spotting on the fence.
- In 2023 the sacrificial plates at ground level on the posts were adjusted to compensate for ground settling.
- There are a few sections that have sagged. This is not significant and can be left for a year.
- One Bottom stringer has pulled away from the post. Occasionally top or bottom stringers will pull away, mostly due to wind action. The fix is simply to reinsert the stringer.
- On the Bridle Estates side of the Condo fence a homeowner has piled landscaping material against the fence. This practise can cause deterioration in the fence

components, discolouration of the finish and unnecessary structural load on the panels and post.

Figure 4 Vinyl condo fence with material piled against the fence on the Bridle Estates side

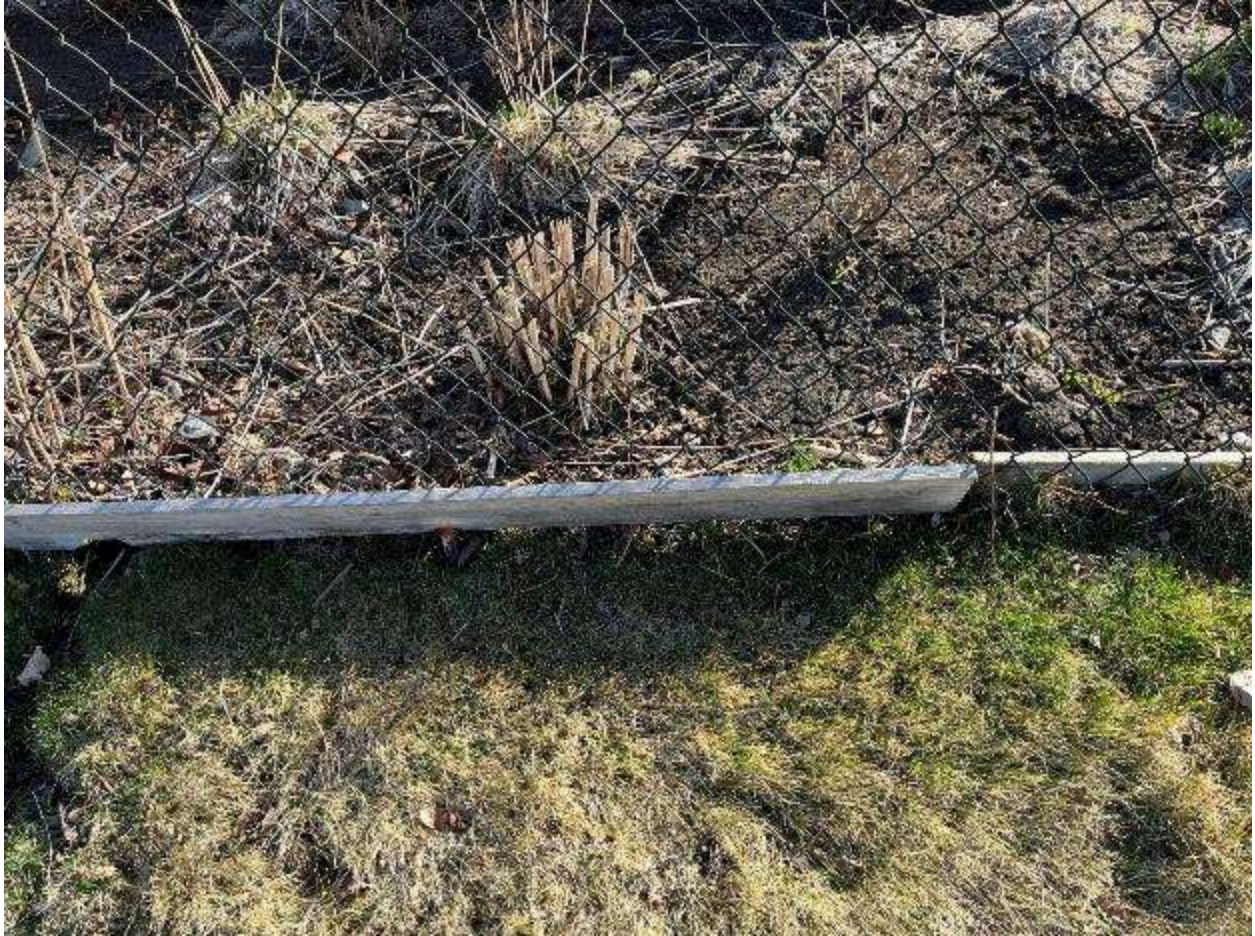
Figure 5 Chain link fence showing material piled against the fence placing extra load on the wire stringer and chain links

1. A general communication should be sent to homeowners to address the issue of piling any material against the chain link fence.
2. Consideration should be given to hiring contractors to repair the deficiencies identified in the observations. This is not urgent. Some fixes are minor and could be repaired by volunteers.

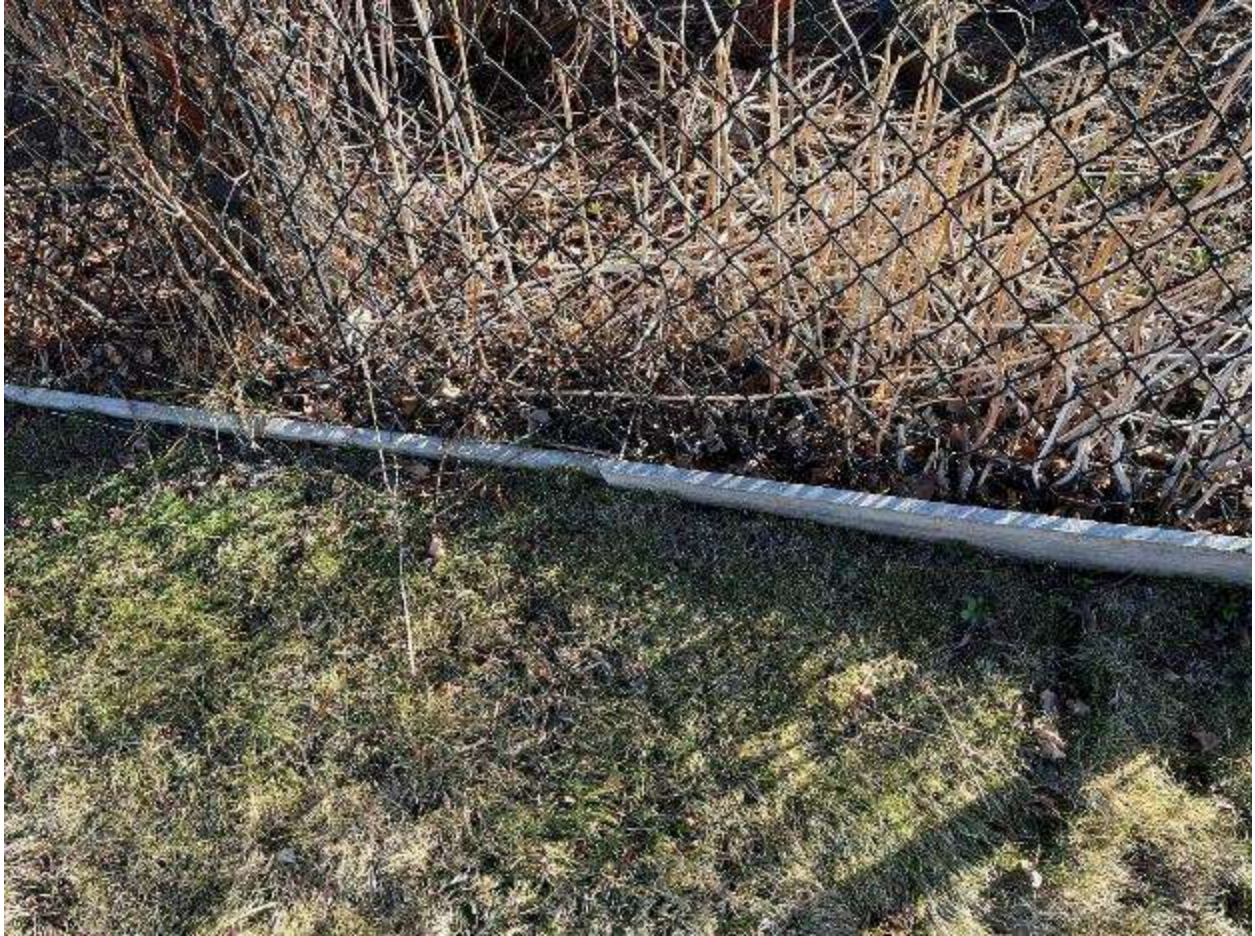
Figure 6 Chain link fence showing typical material loading the wiring stringer and chain links

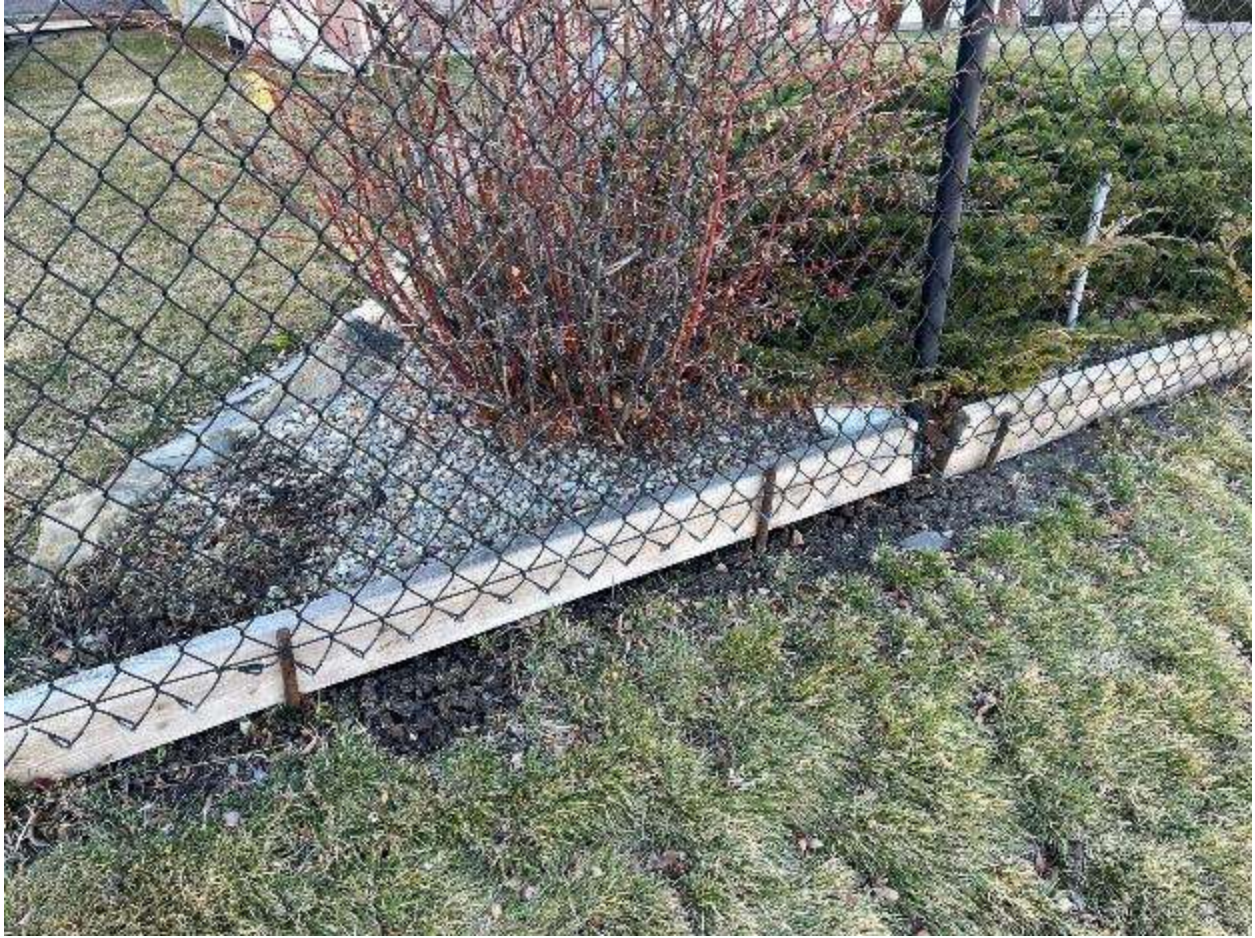
Figure 7 chain link fence with reduced loading on the wire stringer and chain link provided by the board and rebar

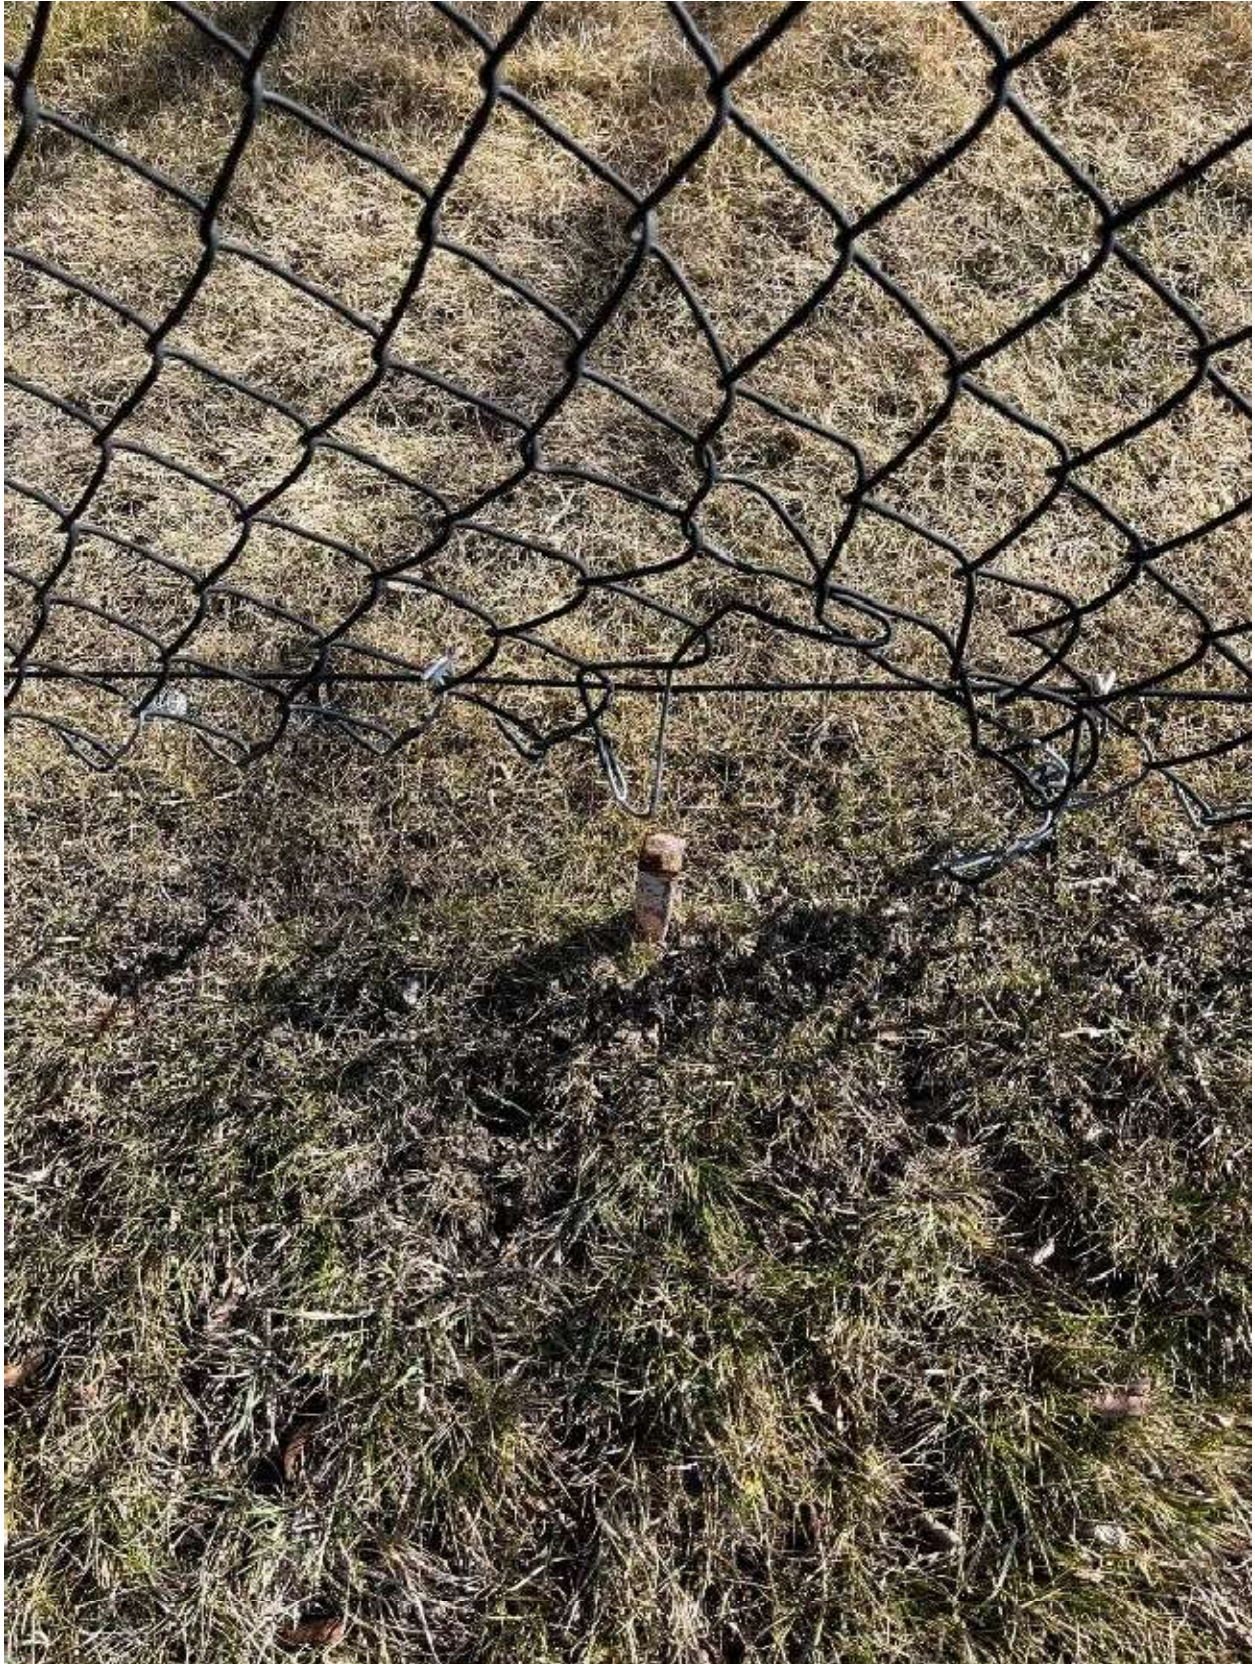
Figure 8 Chain link indicating separation

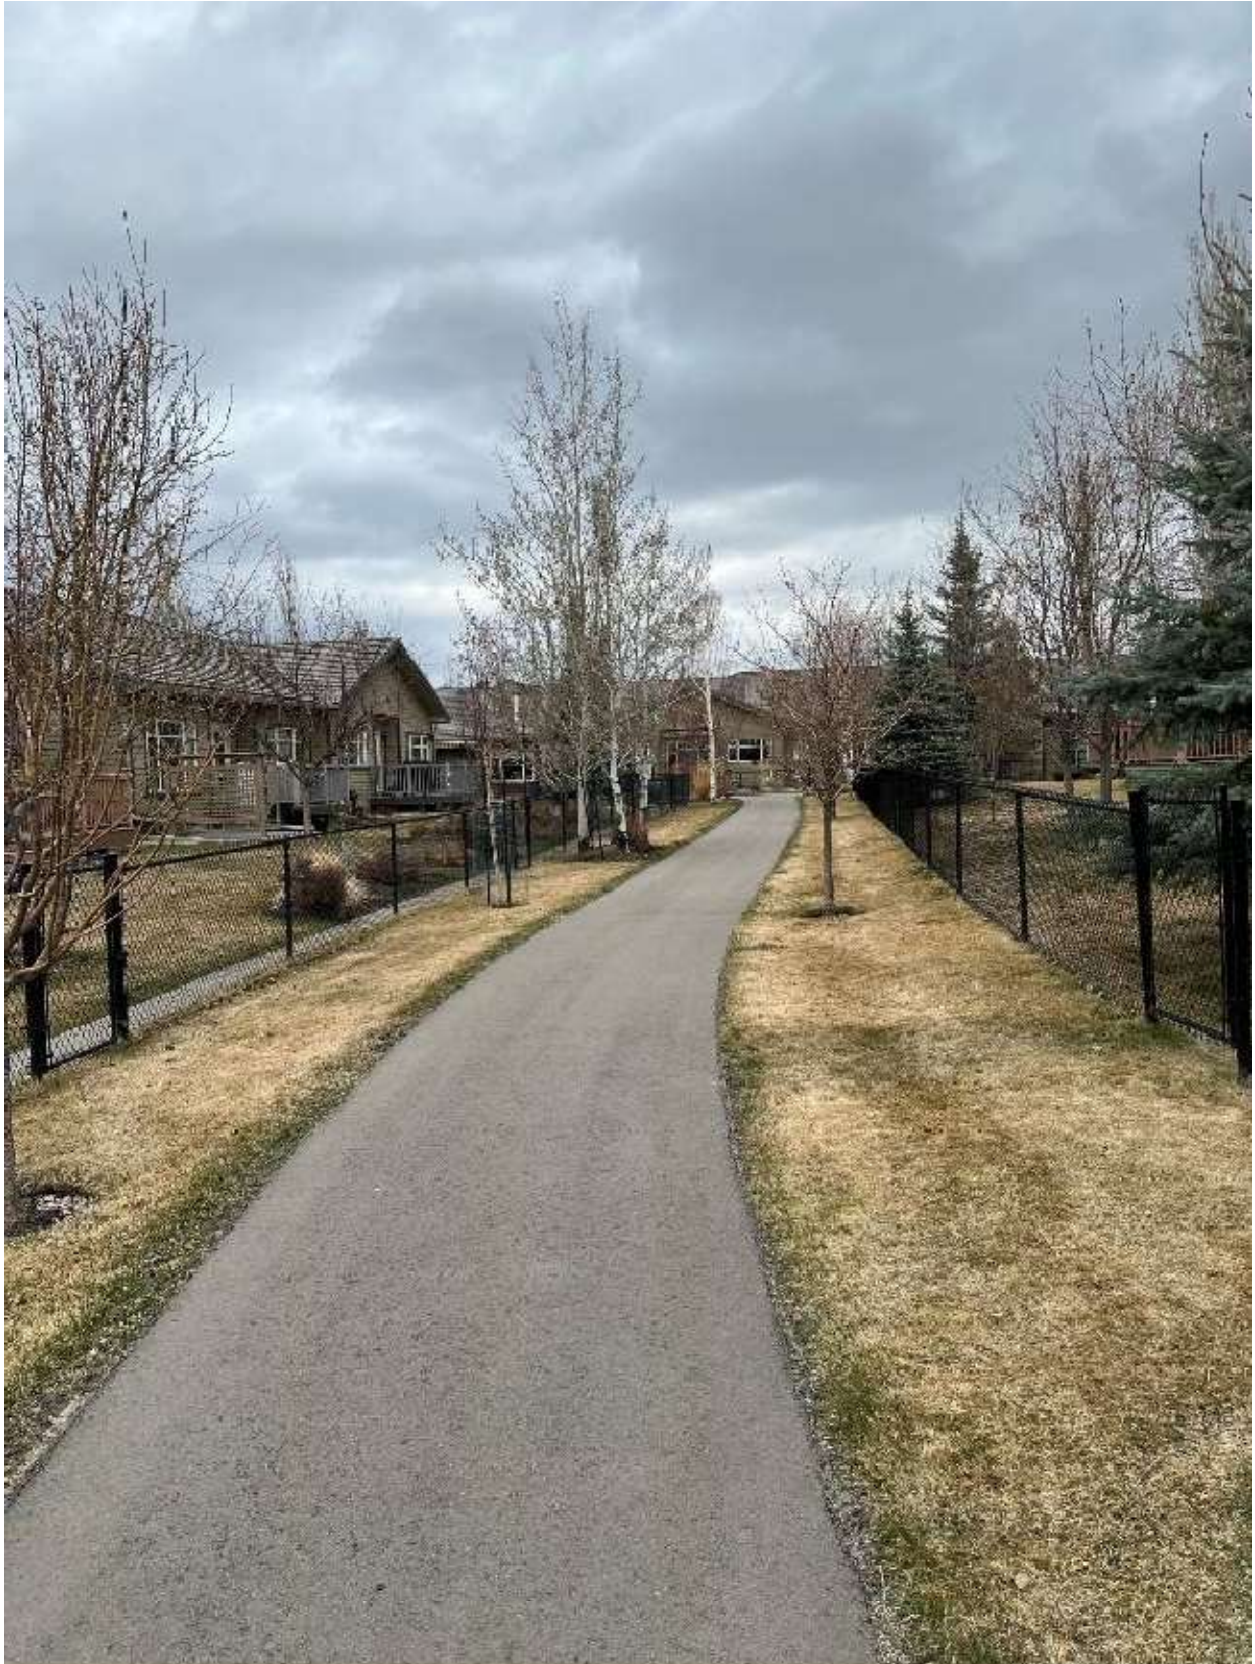
Figure 9 Typical section of chain link fence along the linear path

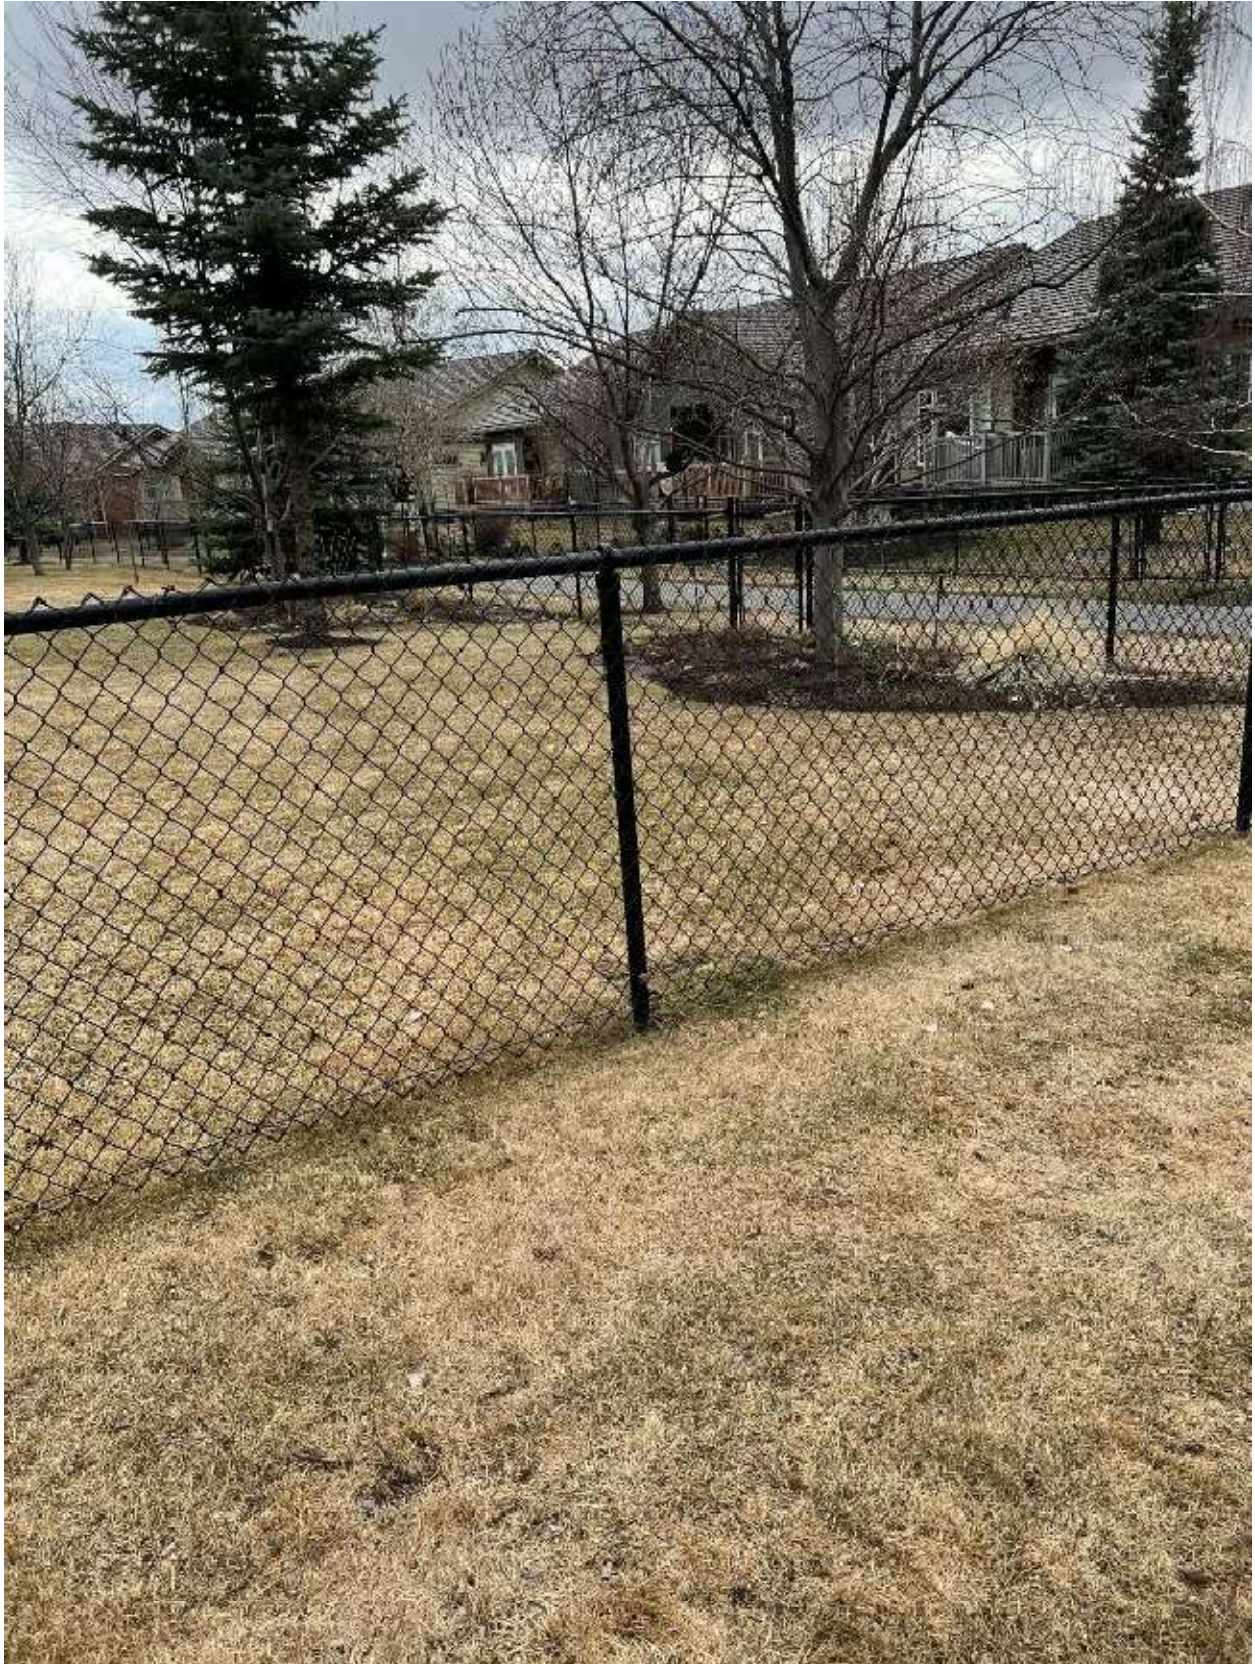
Figure 10 Chain link fence as it should be, no loading on the bottom stringer and chain links.

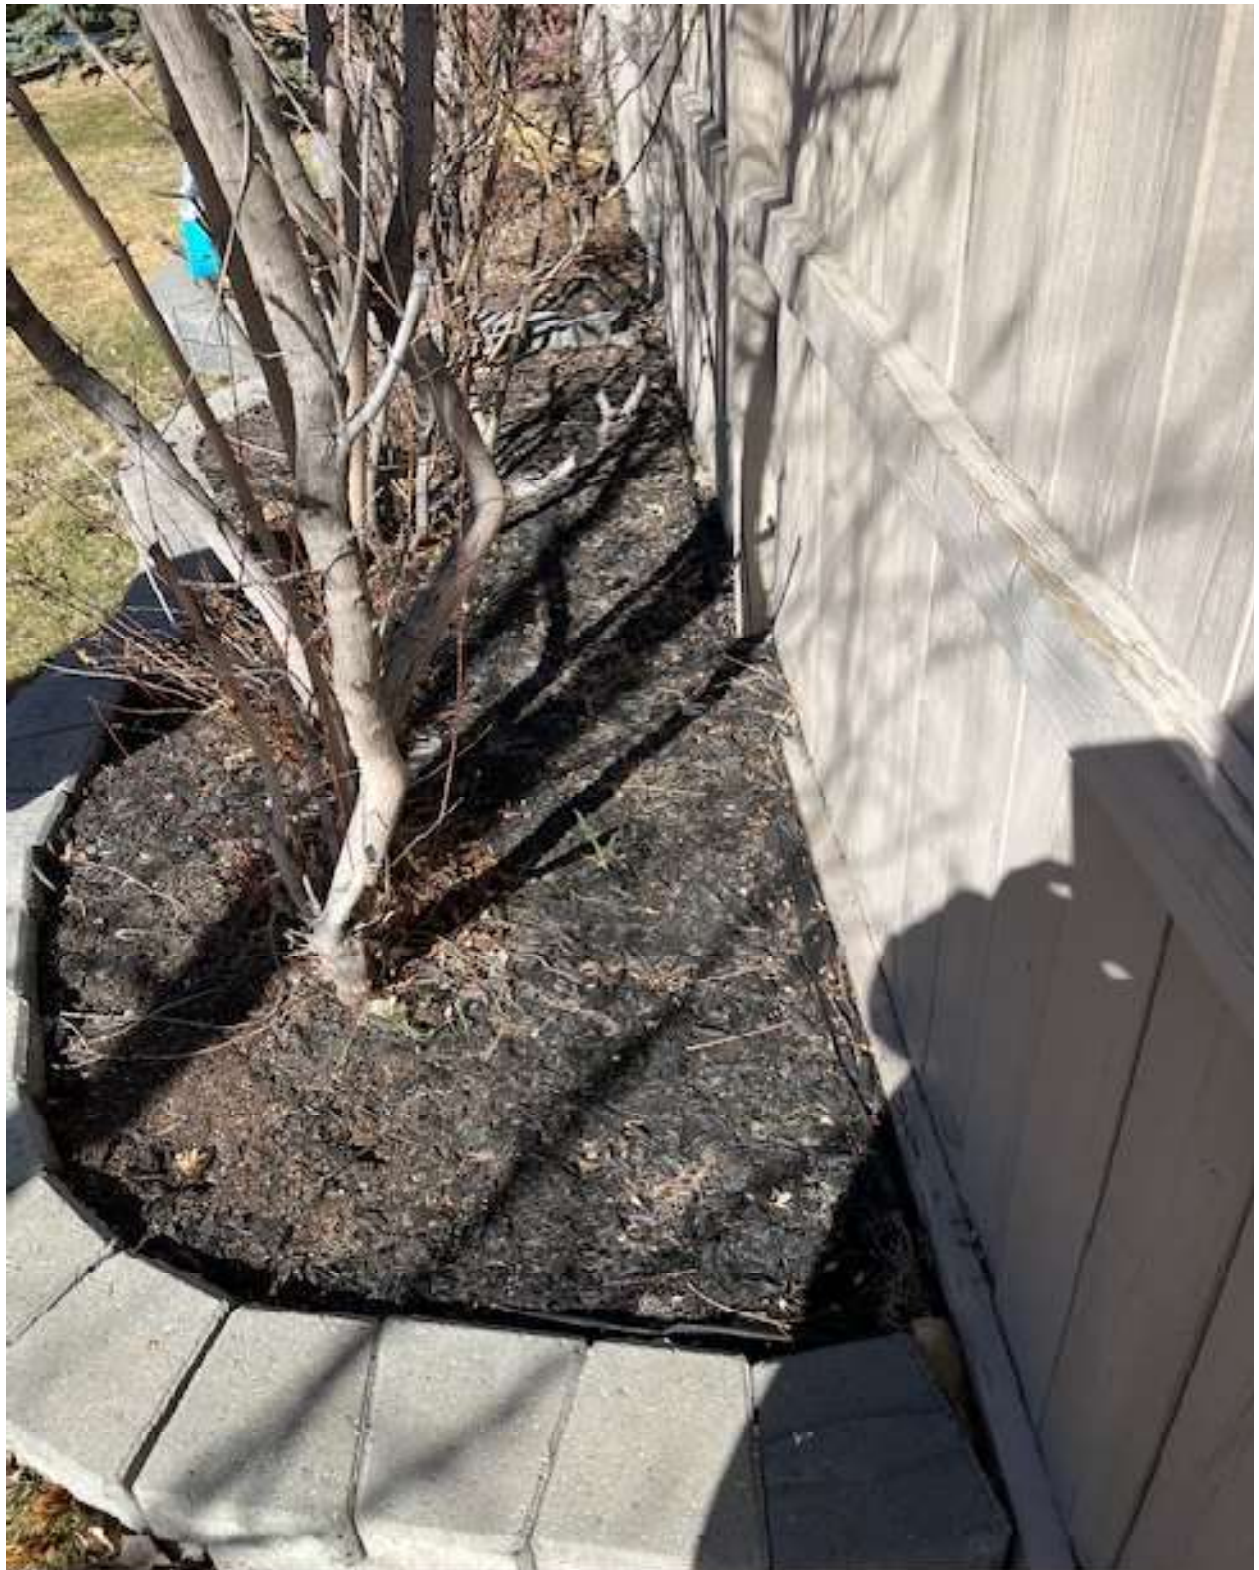
Figure 11 Material next to the fence captures moisture and accelerated deterioration of the wood.

- Home owners should be informed that all material or items should be pulled back from the fence leaving an air gap. Trees shrubs and bushes should not be permitted to contact the fence.
- Trees and shrubs will require trimming so there is no contact with the fence.
- Maintenance is required on this section of the fence to address structural issues; cap the post by the end of the condo vinyl at 225 Bridle Estates Road and repair the rails at 217 Bridle Estates Road.
- Painting or staining of this section of the fence is required to prevent further deterioration of the wood and to restore the appearance.

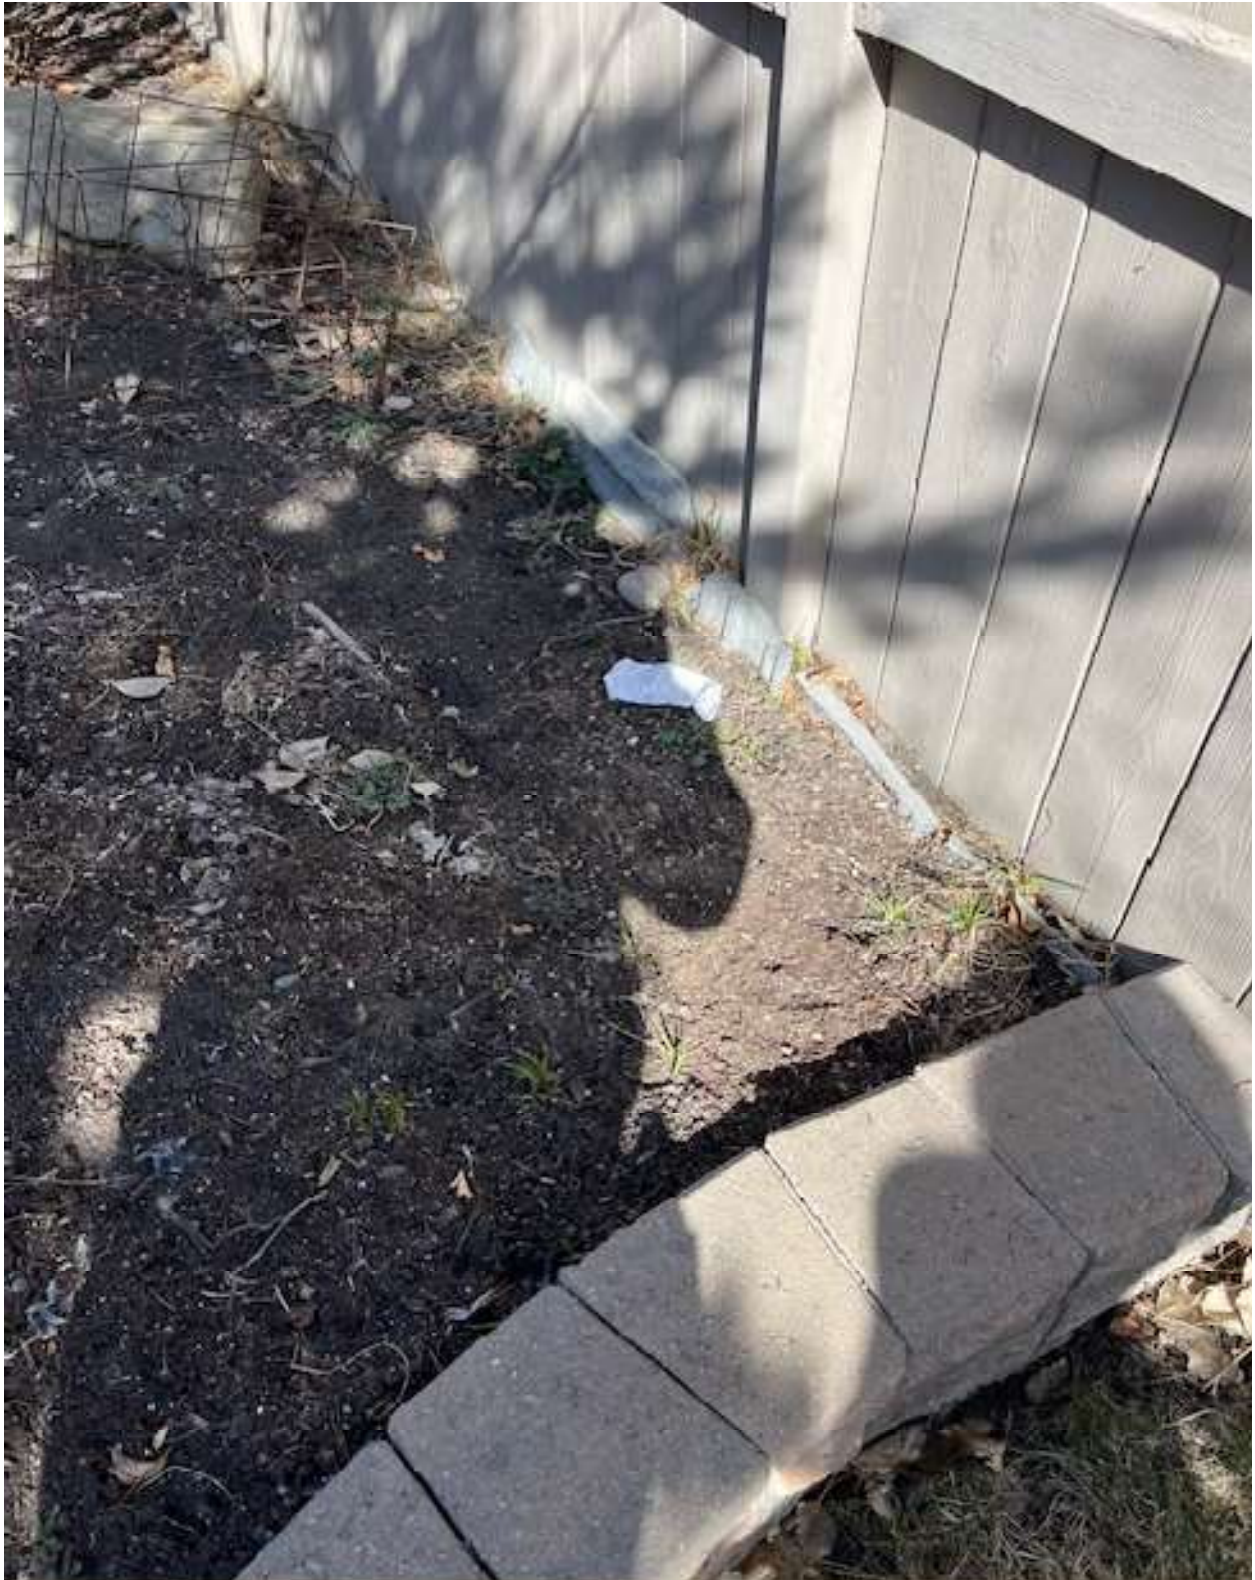
Figure 12 an example of material piled next to the fence retaining moisture and accelerating decay of the wooden rail and boards

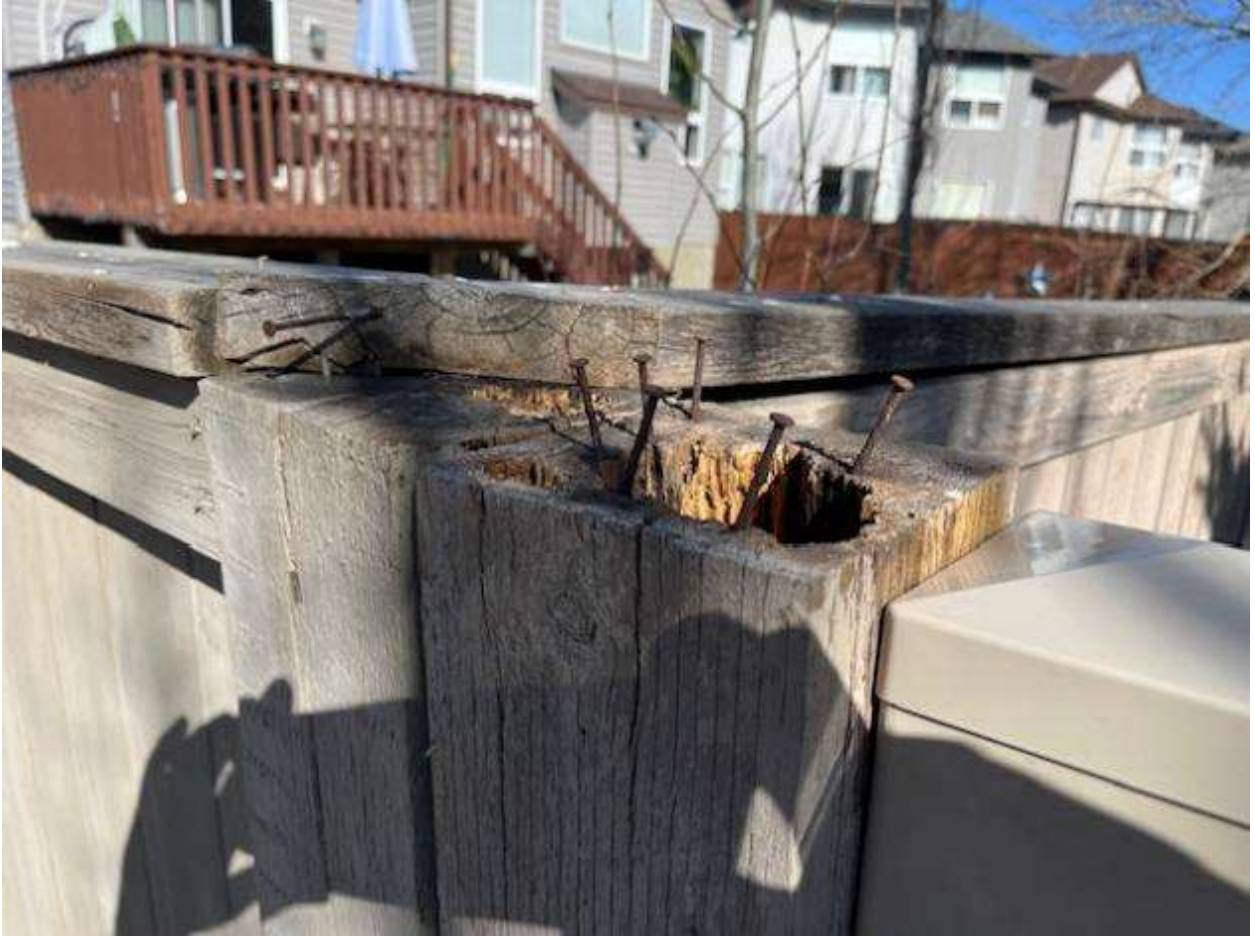
Figure 13 Post cap missing accelerating decay of the post.

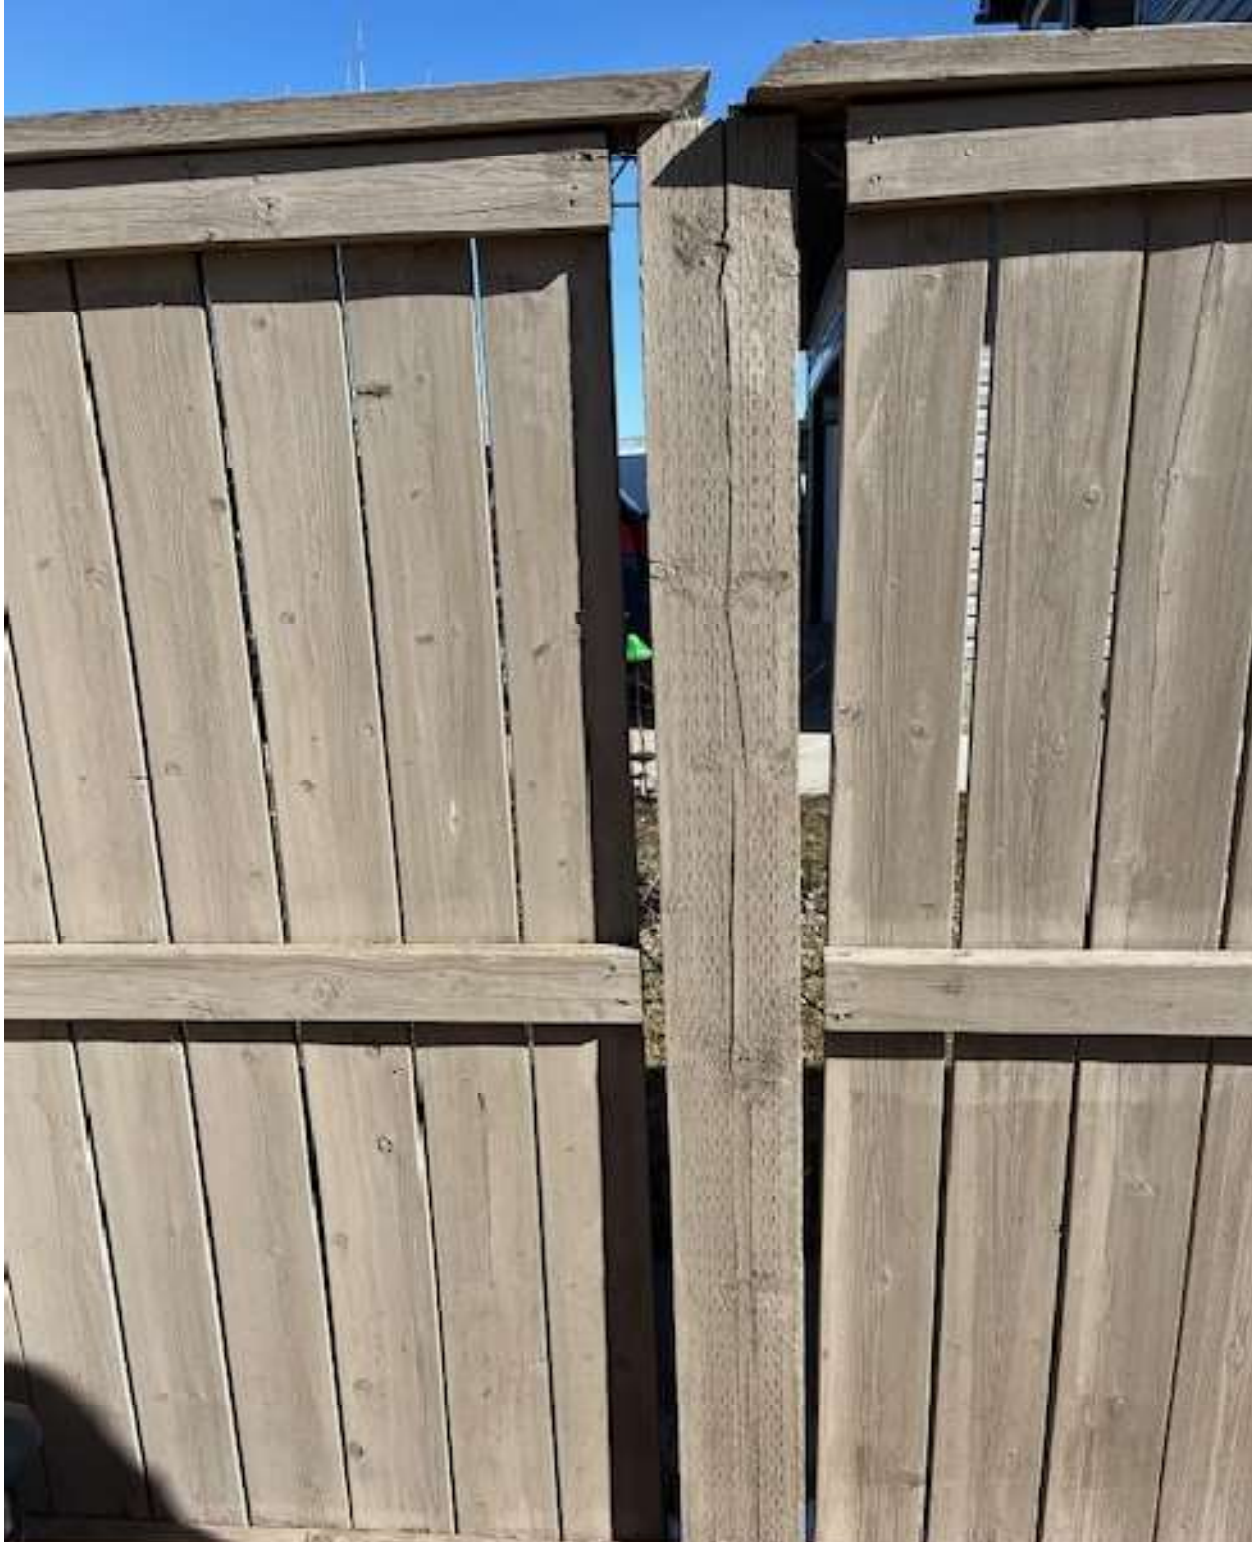
Figure 14 fence components separating from the post.
