Bridle Estates Home Owners' Association
Fence Inspection
And
Maintenance Recommendations
April 14, 2025

April 14, 2025
Barry Manovich
Max Lewin
Randy Parsons
Bruce Sorge
Dwayne Thomas
Byron Turner

Summary

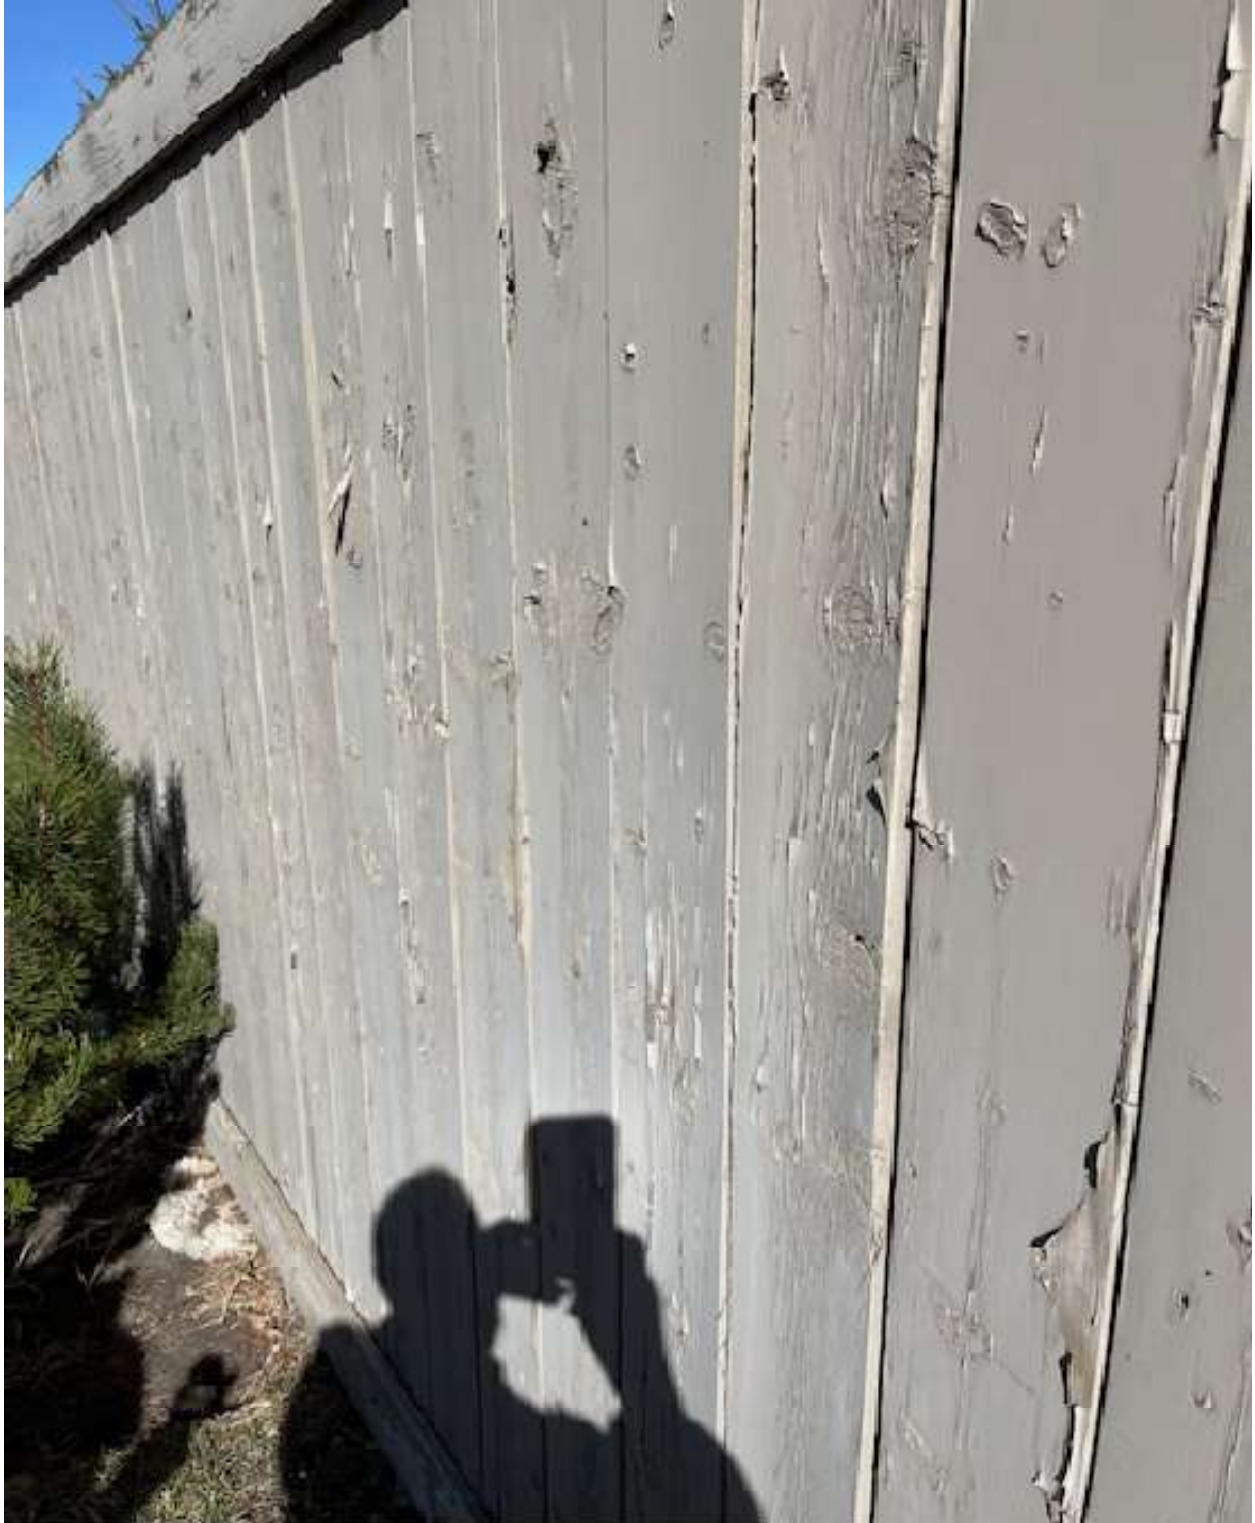
Figure 15 stain/paint peeling

- Home owners should be informed that all material or items should be pulled back from the fence leaving an air gap. Trees shrubs and bushes should not be permitted to contact the fence.
- Trees and shrubs will require trimming so there is no contact with the fence.
- Maintenance is required on this section of the fence to address structural issues; cap the post by the end of the condo vinyl at 225 Bridle Estates Road and repair the rails at 217 Bridle Estates Road.
- Painting or staining of this section of the fence is required to prevent further deterioration of the wood and to restore the appearance.

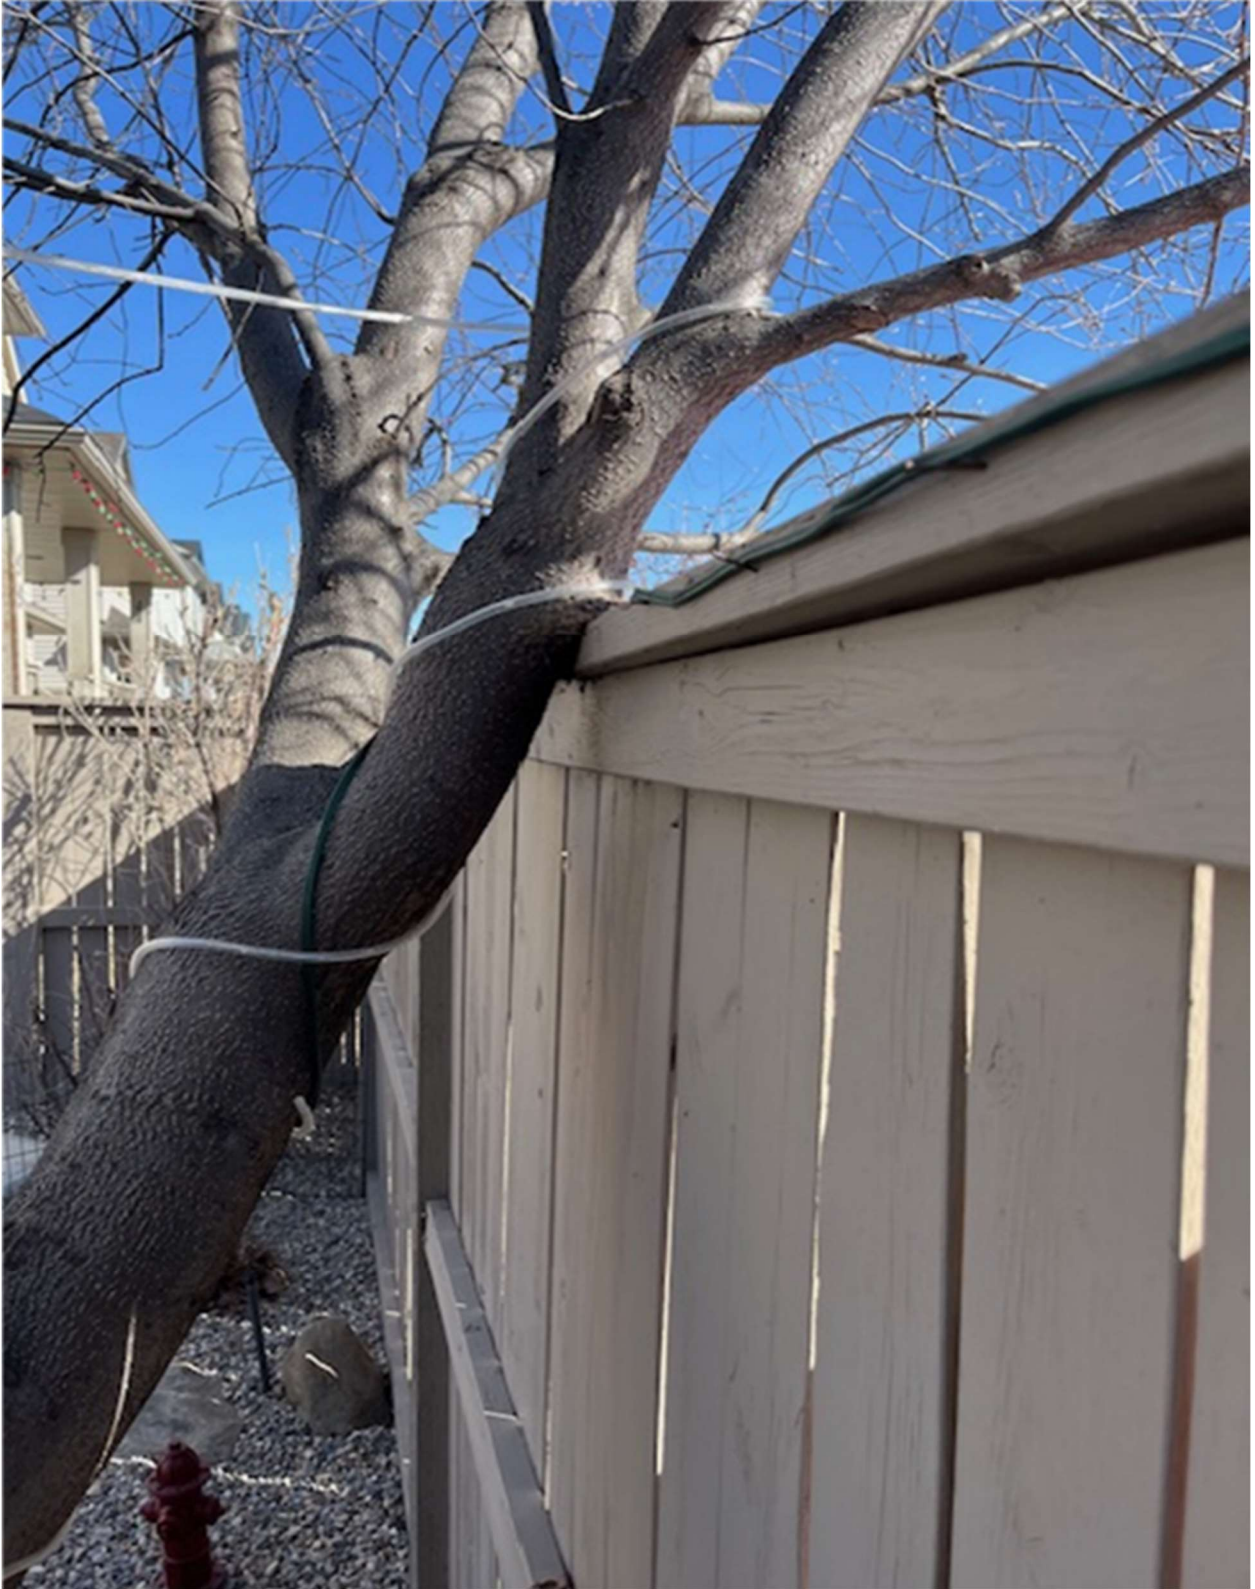
Figure 16 Branch leaning against the fence

The branch leaning against the fence should be removed

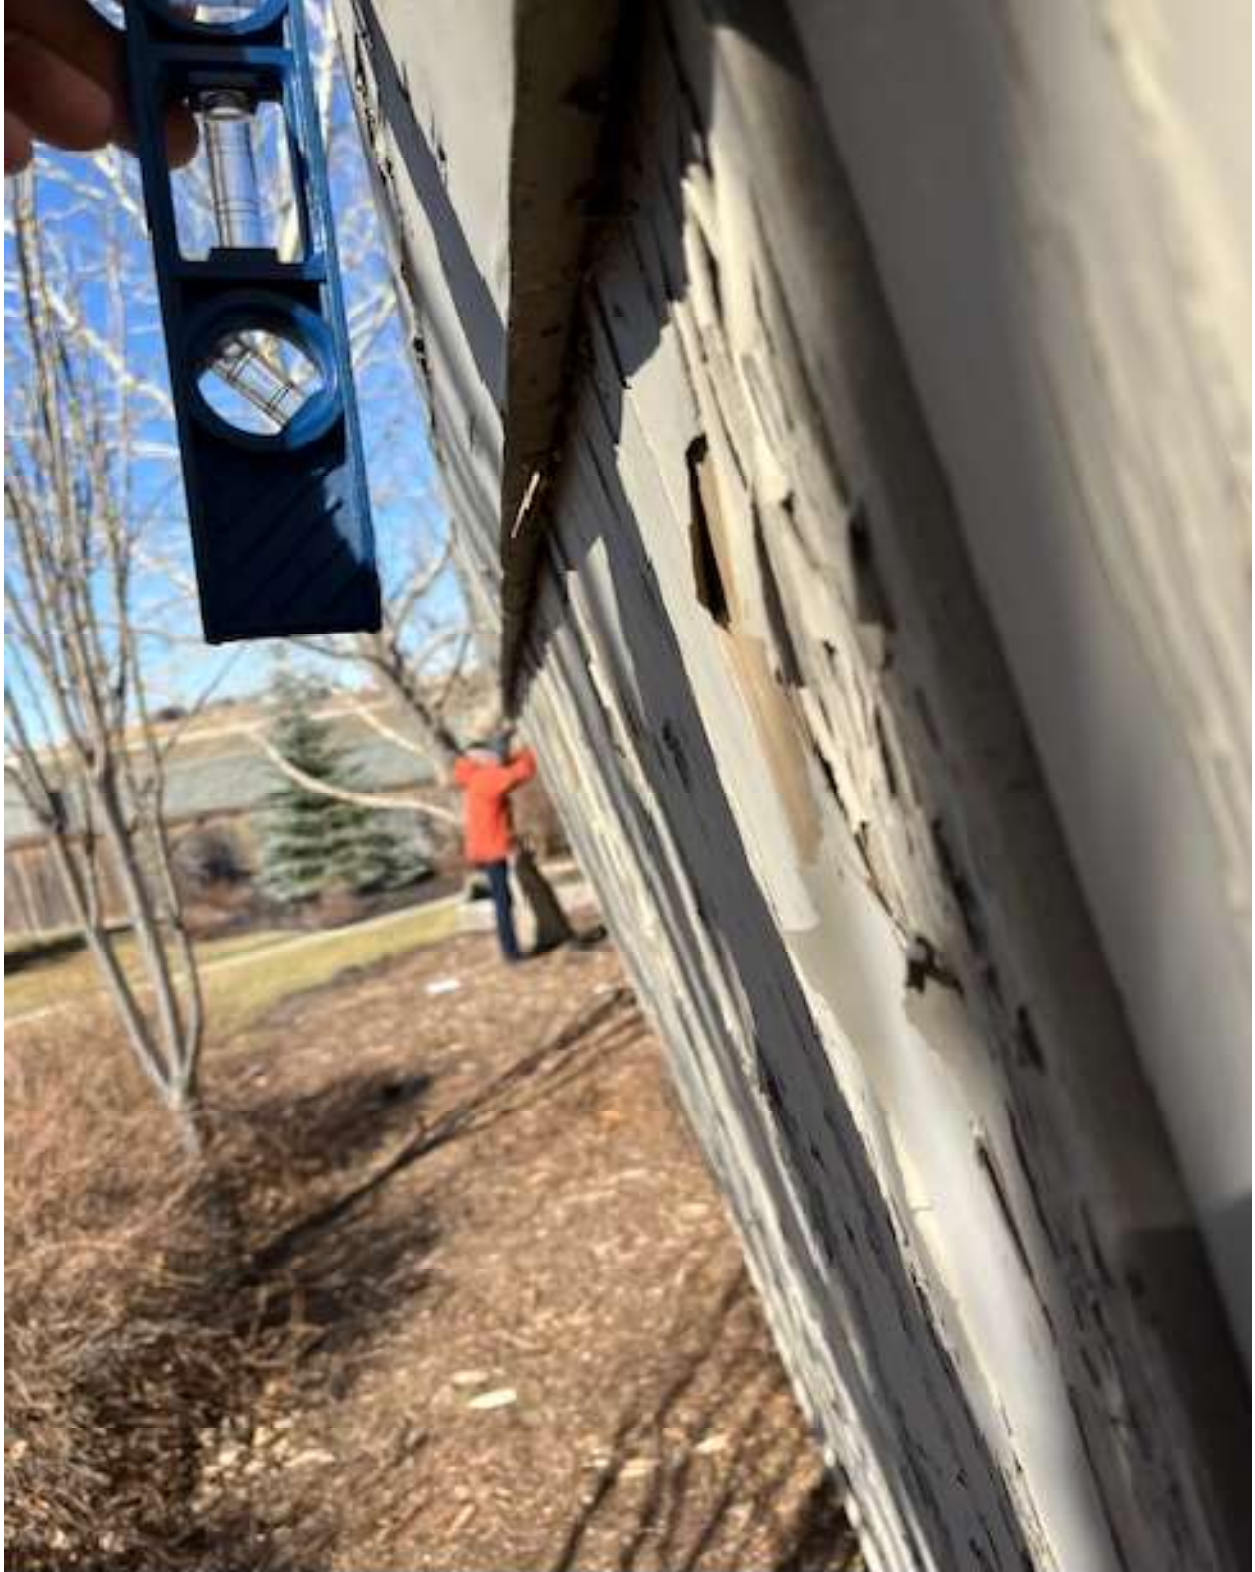
Figure 17 Fence leaning at least 20 degrees

Due to the present state of the fence behind 137,141,145,149, and 153 Bridle Estates Rd, replacement of this section of fence with vinyl fencing identical to that along 24st is highly recommended. It would be aesthetically more pleasing, less long-term maintenance and in line with the strategy of maintaining the standard of using vinyl fencing to replace deteriorated fencing in Bridle Estates. Although some sections of the fence behind 149 and 153 Bridle Estates Road is in a reasonable state of repair it is suggested that the entire fence behind these villas be replaced for aesthetics.

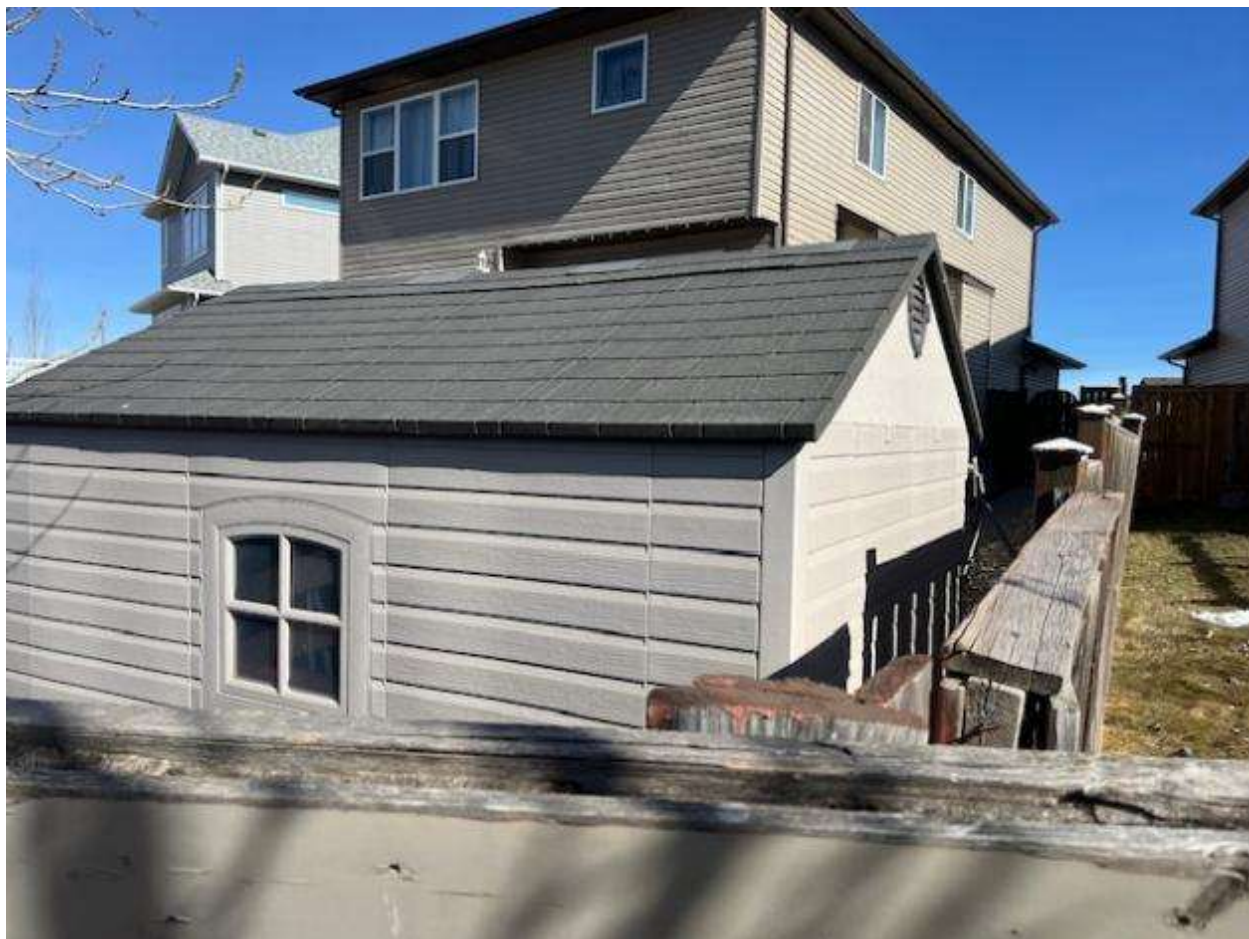
Figure 18 Top plate missing adding to the acceleration of deterioration.

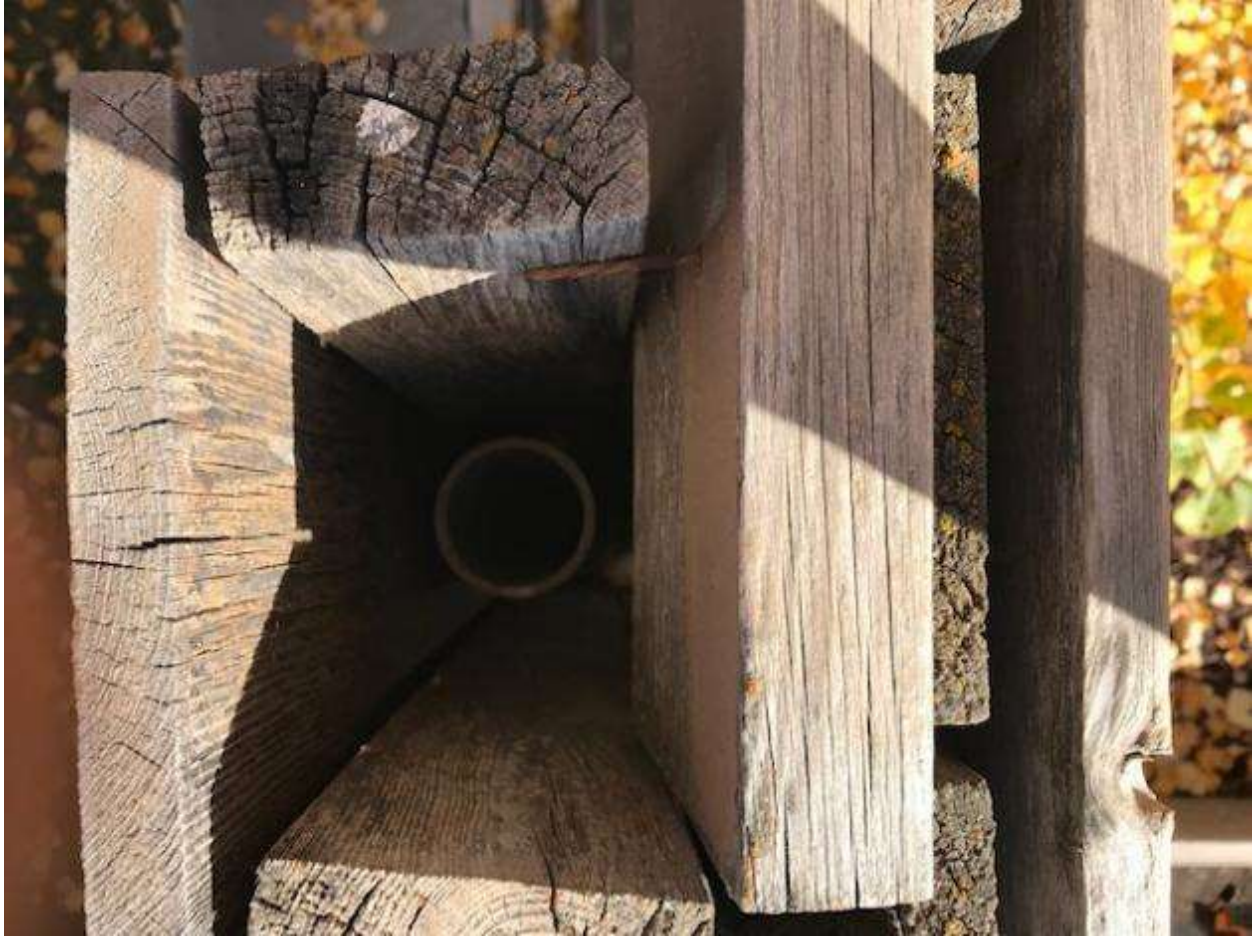
Figure 19 post constructed with wood surrounding a pipe which has contributed to the lean in the fence

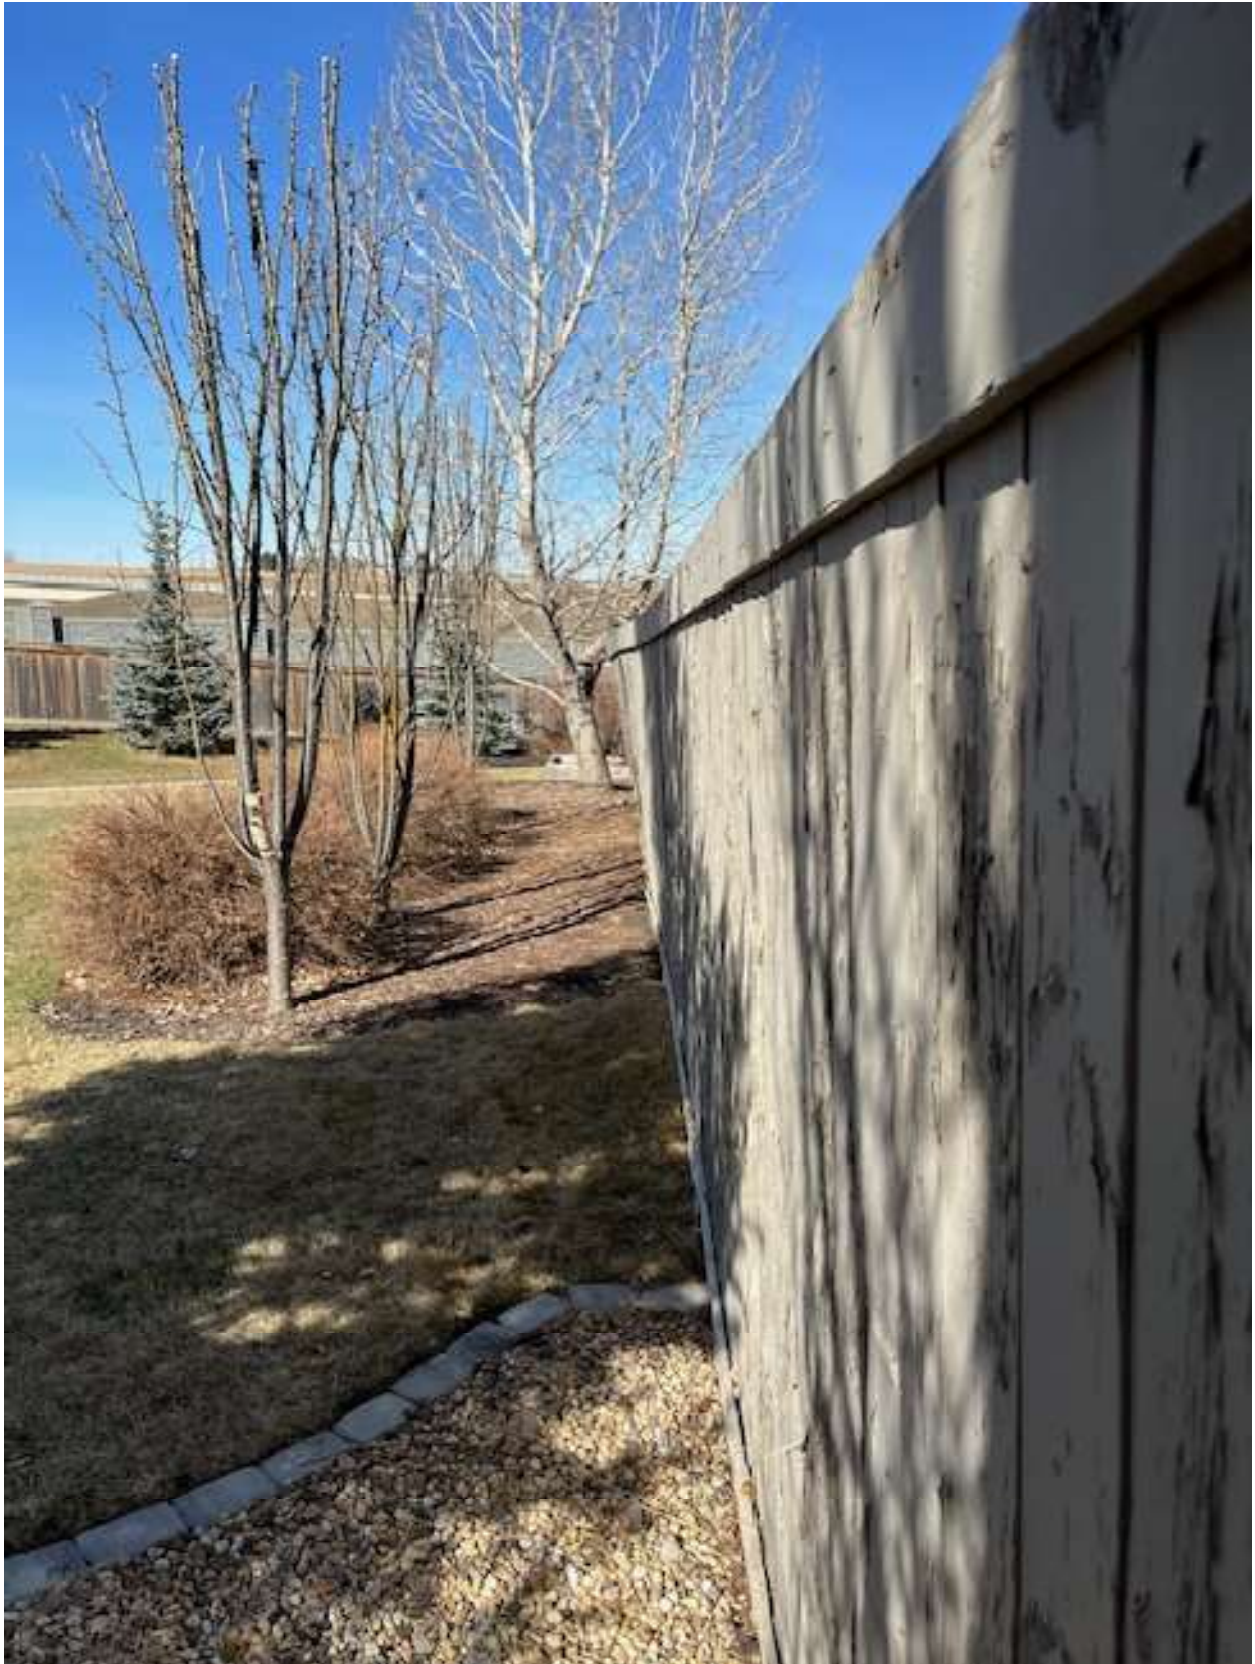
Figure 20 note the bow in the fence and deteriorating boards

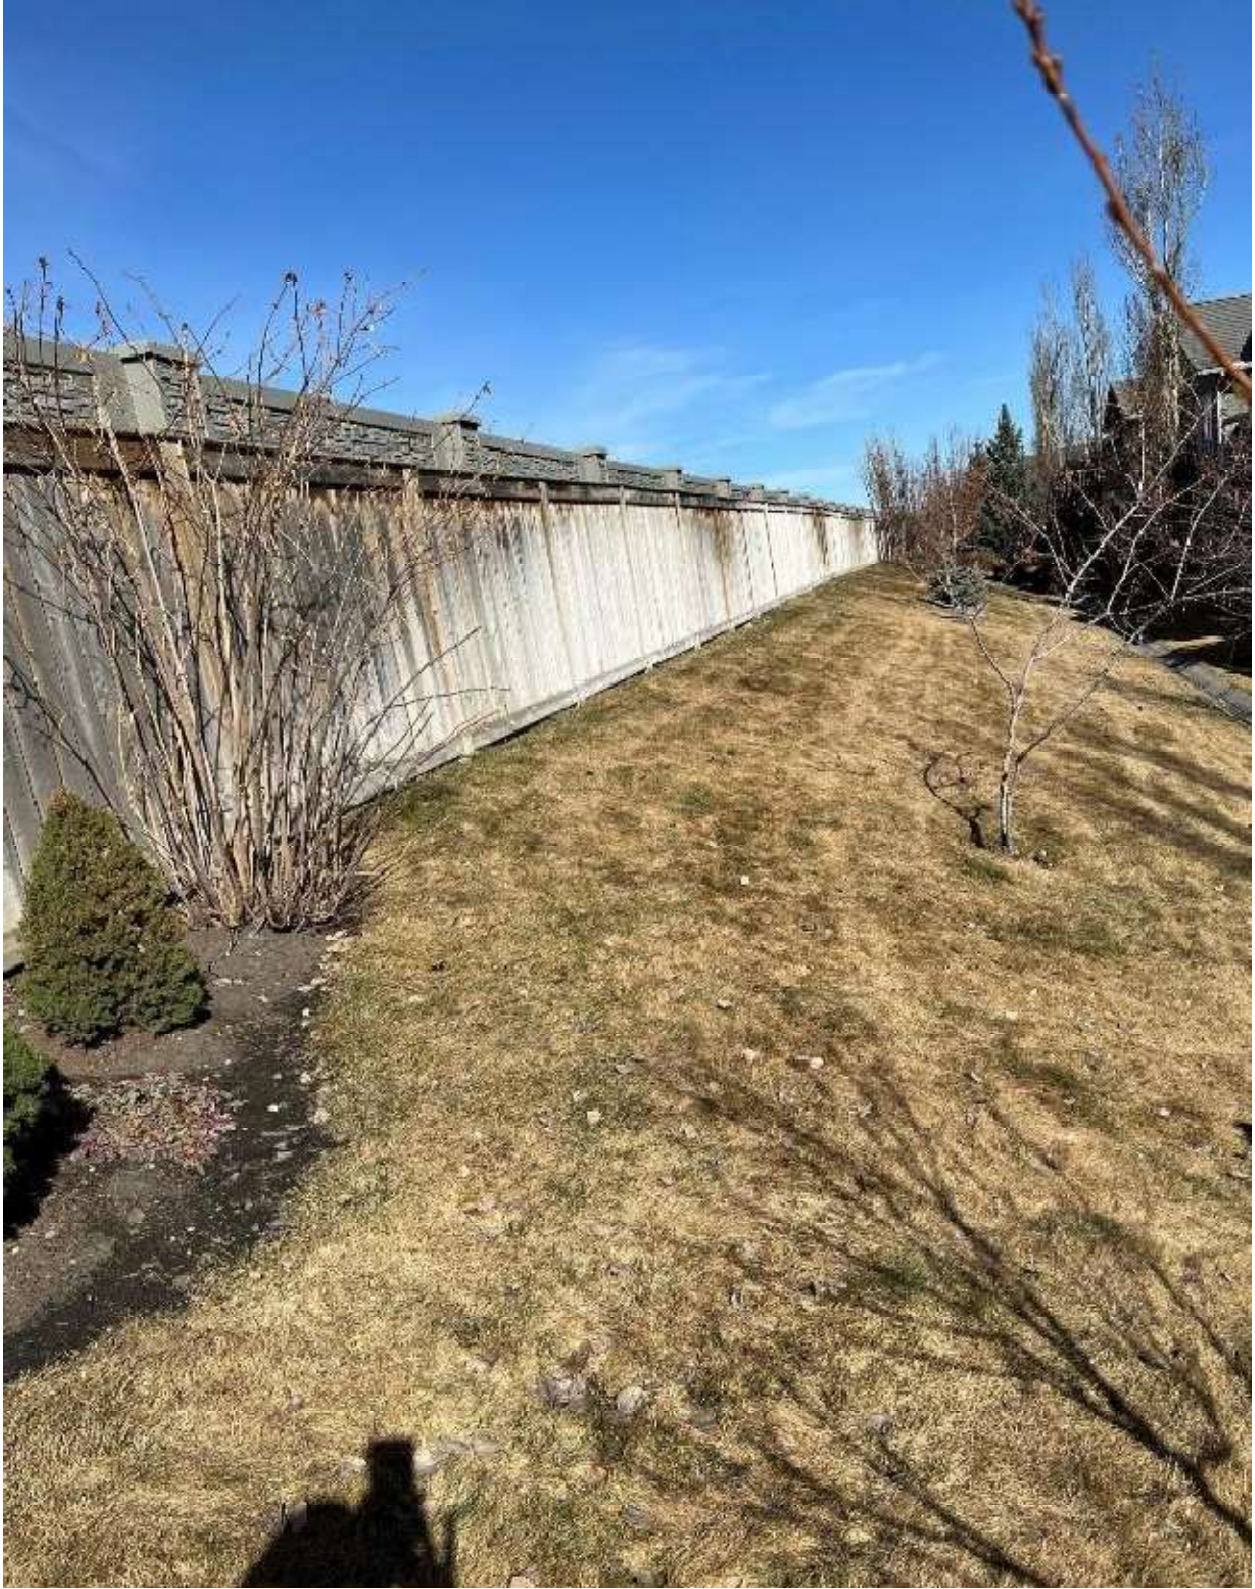
Figure 21 West perimeter fence irrigation sprinkler washed, sun bleached and rustic patina.

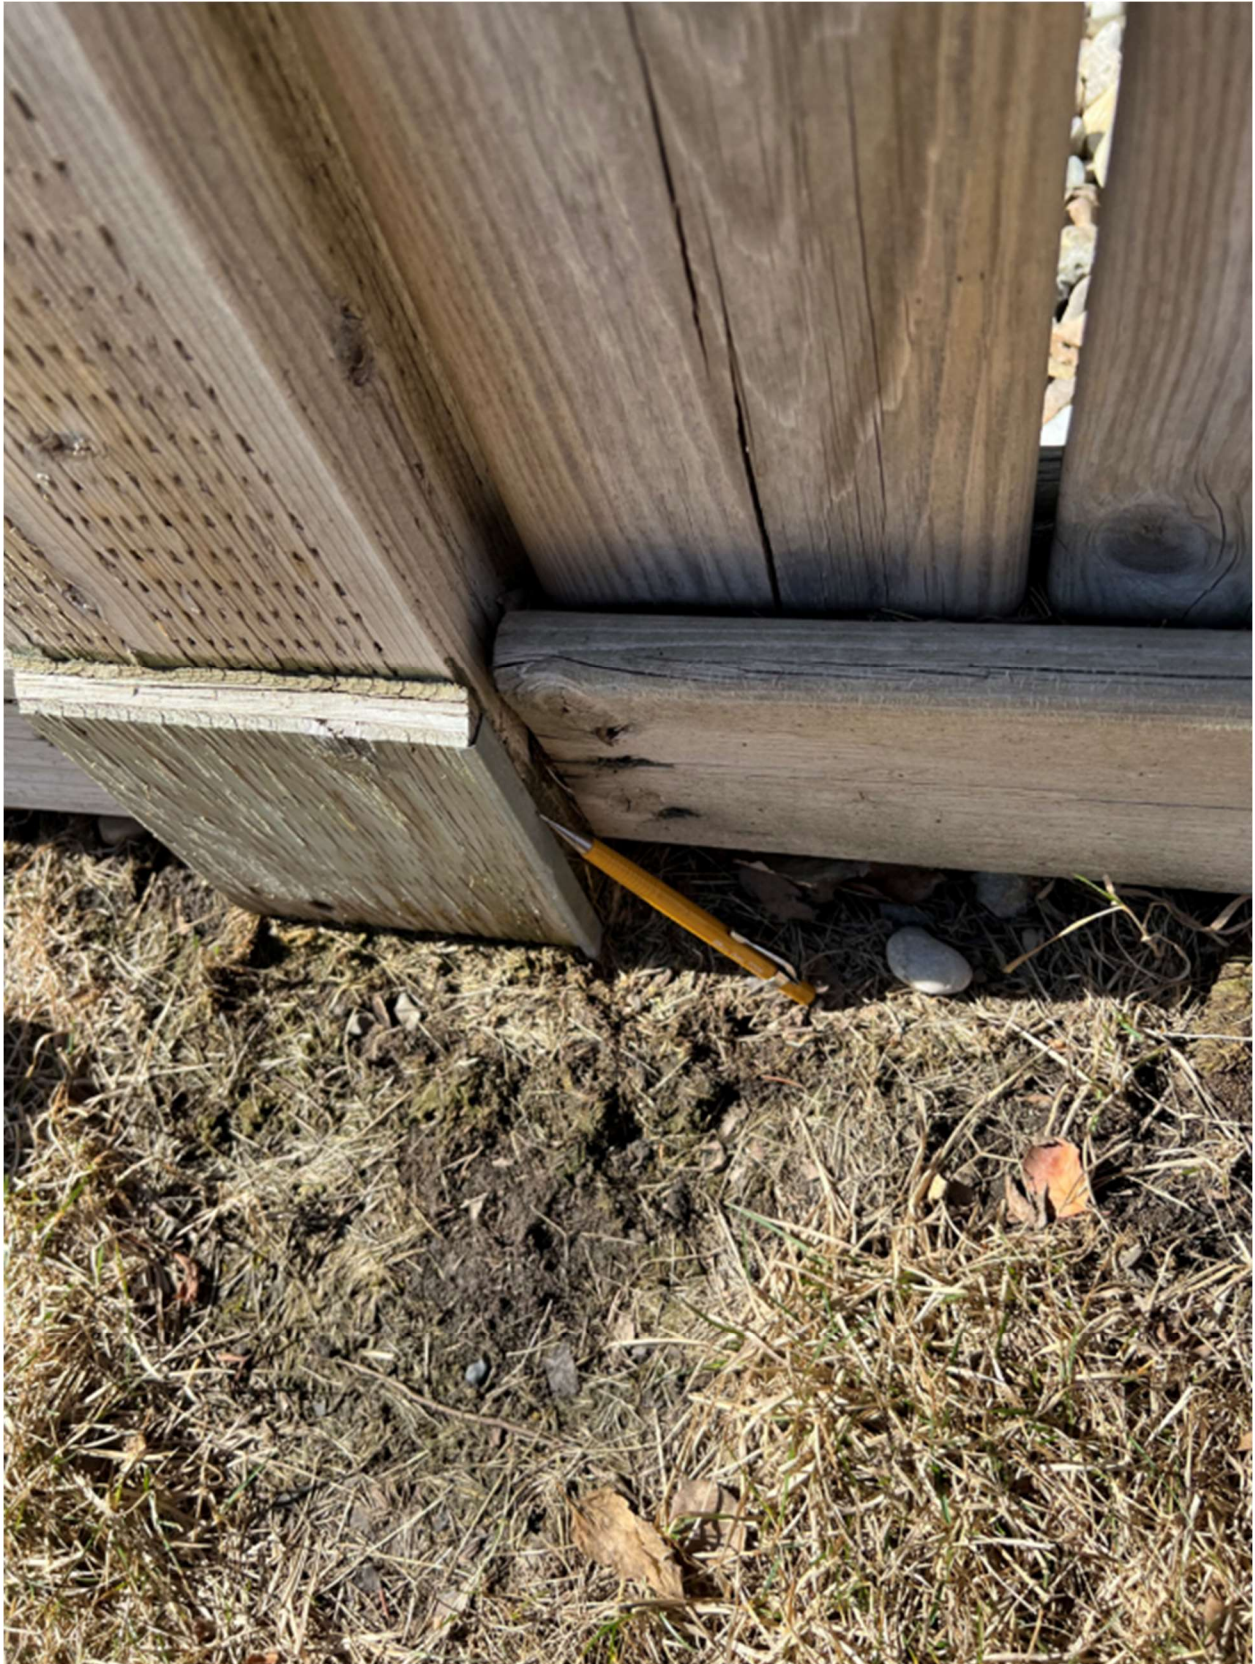
Figure 22 Sacrificial board with metal edge installed in 2016 saved penetrating the PWF water proofing.

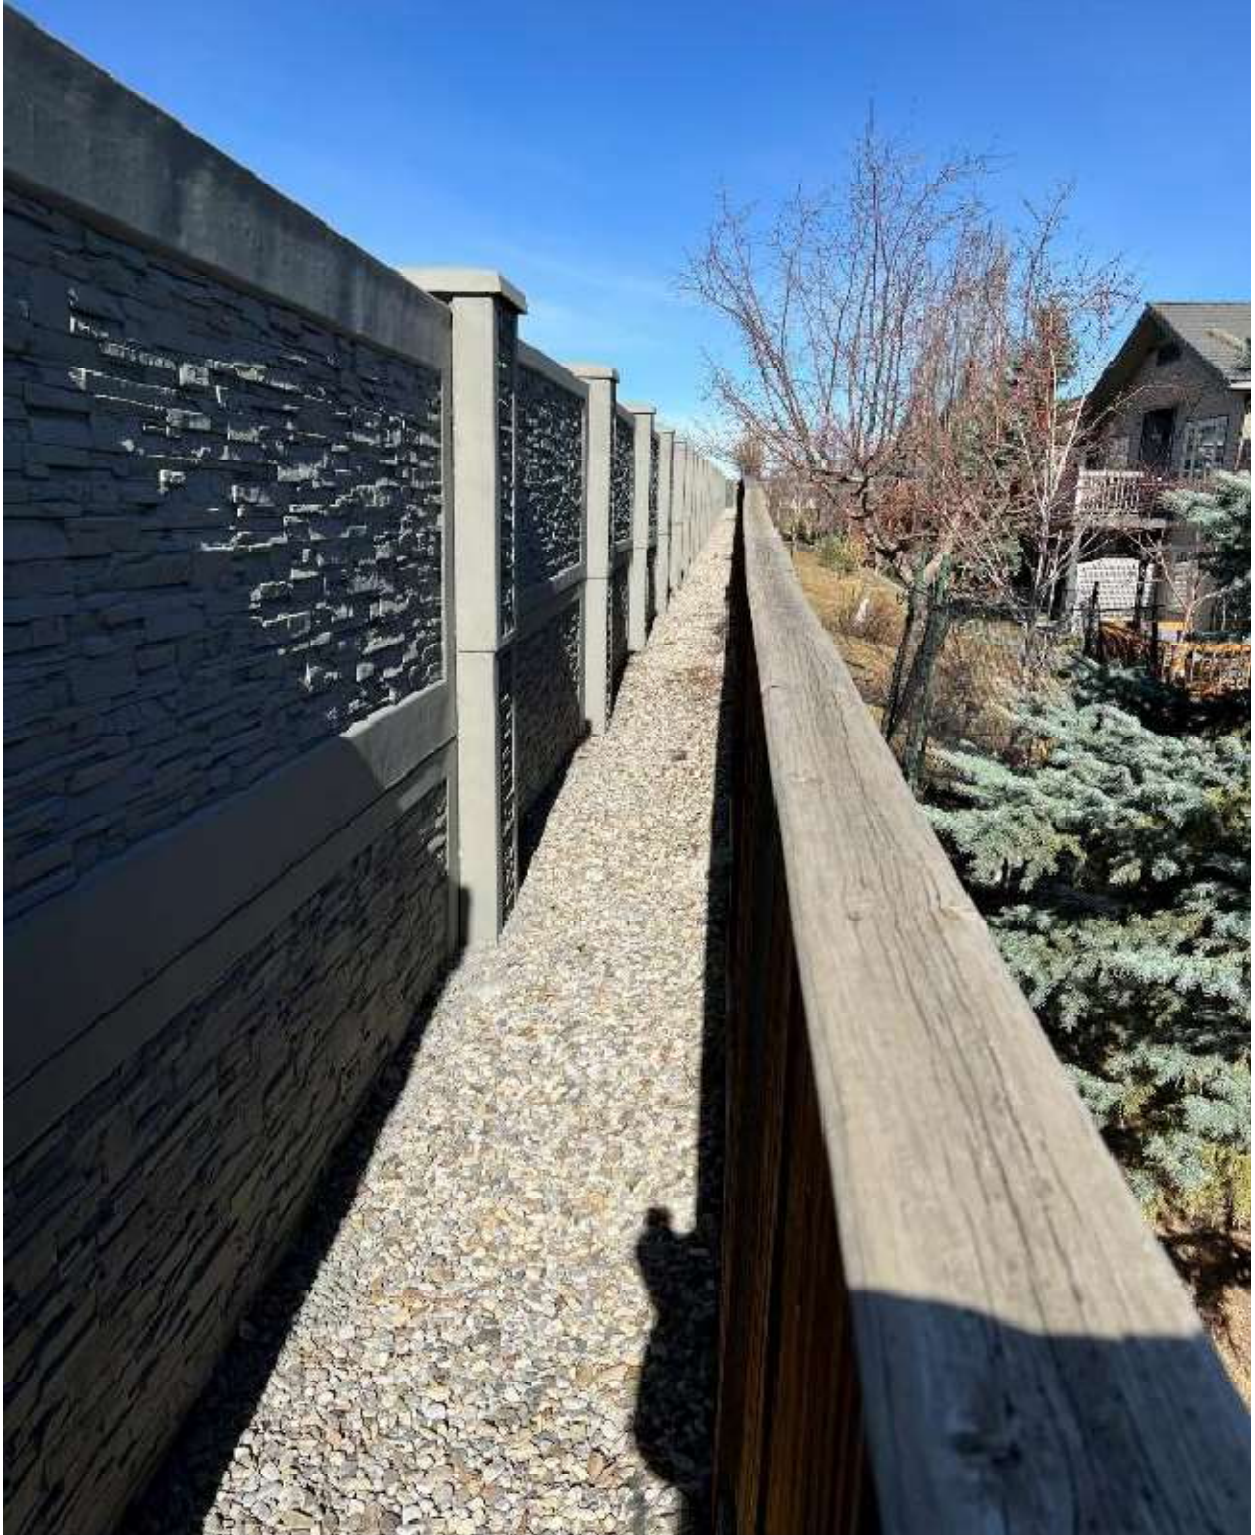
Figure 23 Gap between the sound barrier and west perimeter fence; 3/4 inch crushed layered base between the two fences.

1. The minor repairs such as addressing the barrier board permitting the $\frac{3}{4}$ " crush to seep below the fence and the minor separation of rails from the post should be completed.
2. Weed growth between the sound barrier and wall should be monitored and any growth eradicated.
3. No other maintenance is suggested other than monitoring .

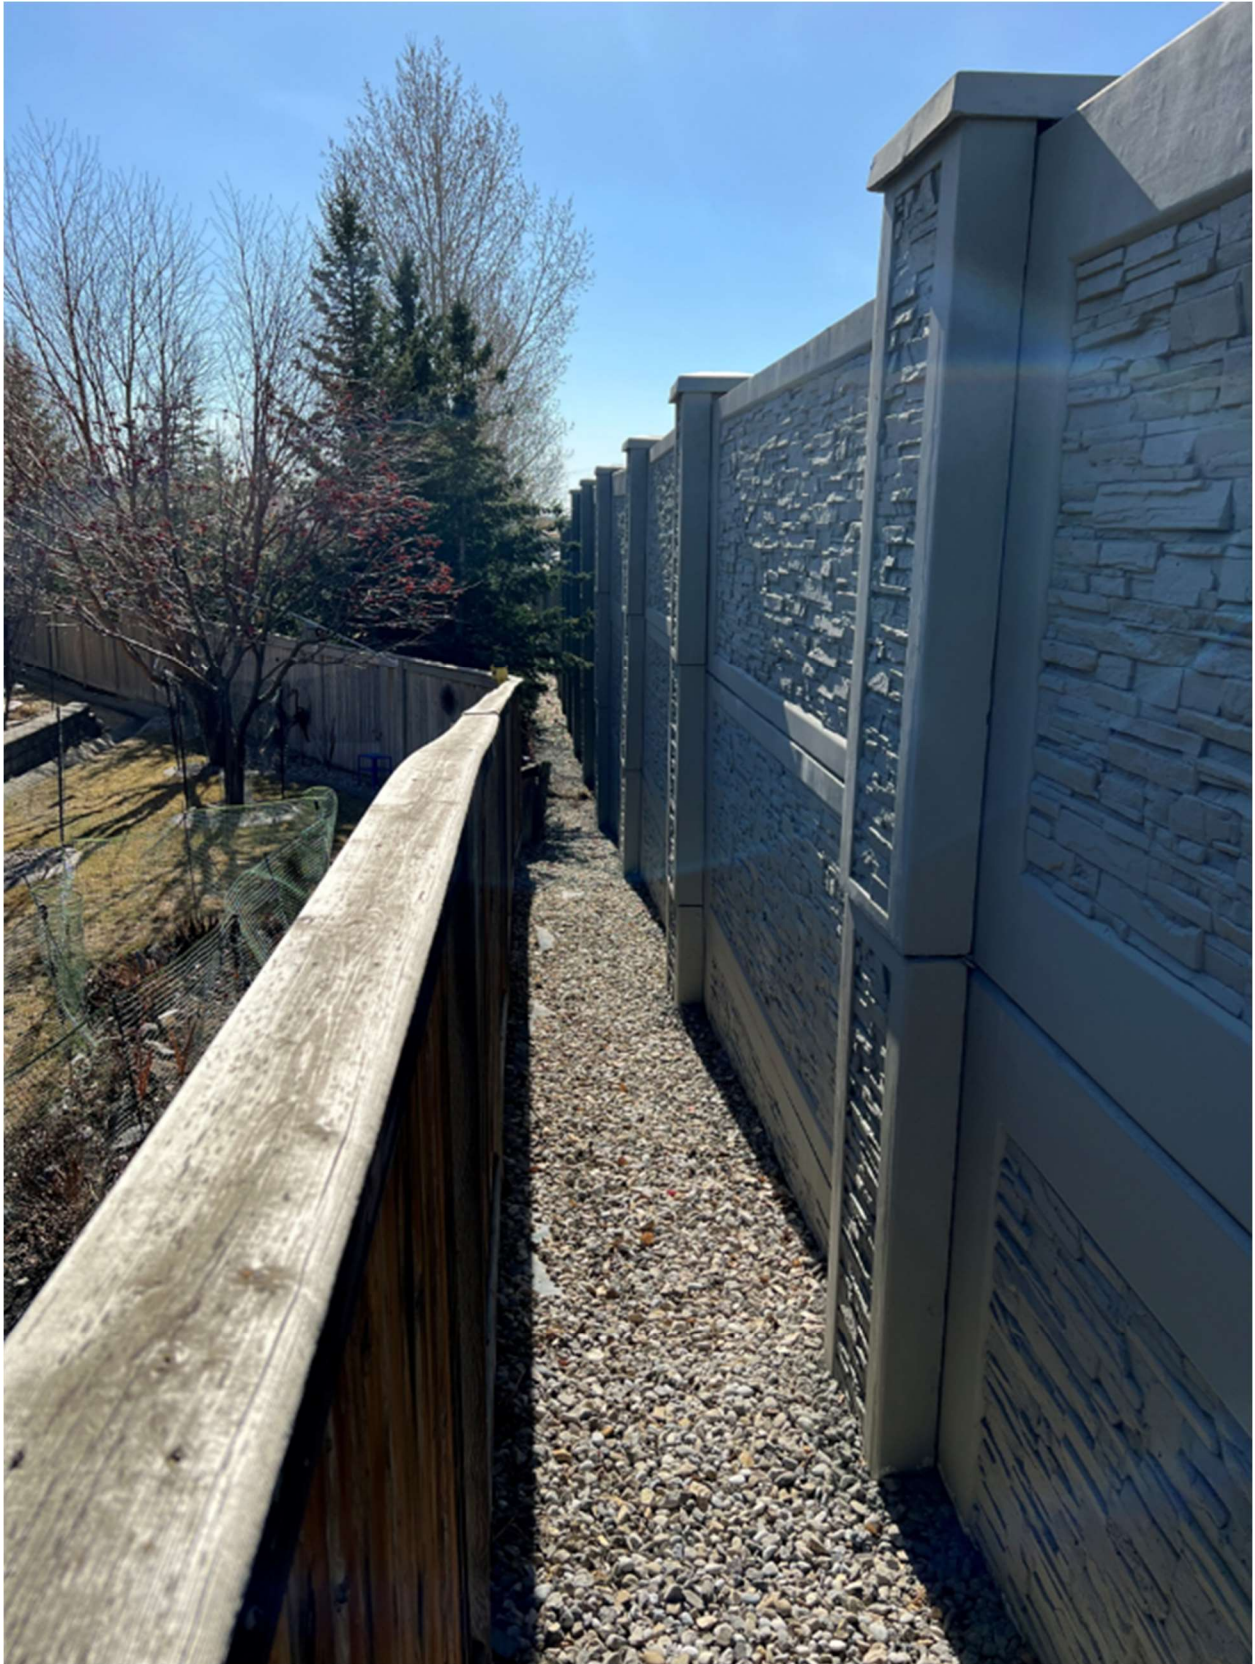
Figure 24 Second view of the gap between the west perimeter fence and sound barrier; note the intact condition of the top plate.

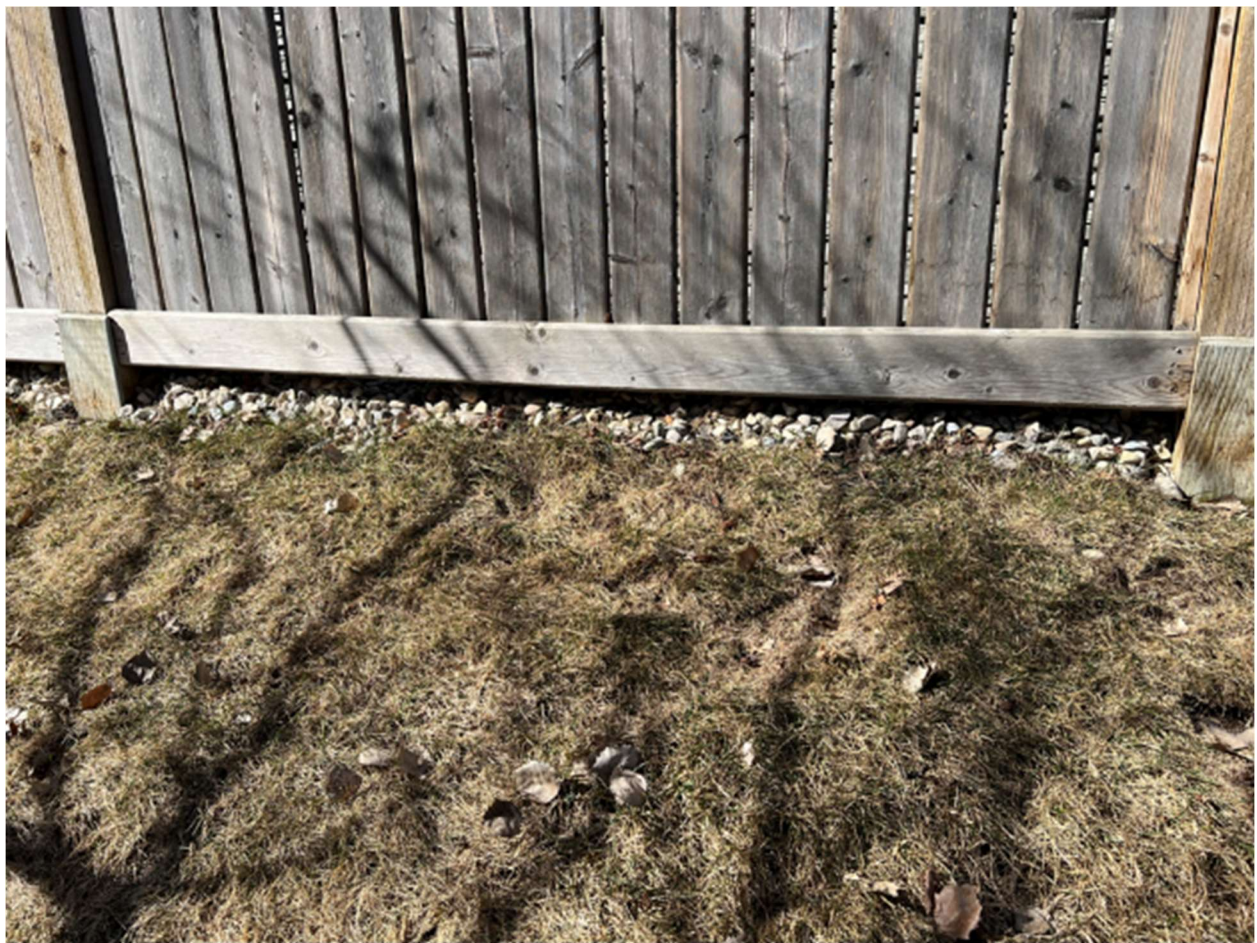
- In a few locations the bottom rail of the fence is above grade and there is a small amount of crushed rock migration from the sound barrier side.
- Some of the posts have twisted and bowed but are solid.

Figure 25 West perimeter fence indicating 3/4 inch plus seeping beneath the bottom rail.

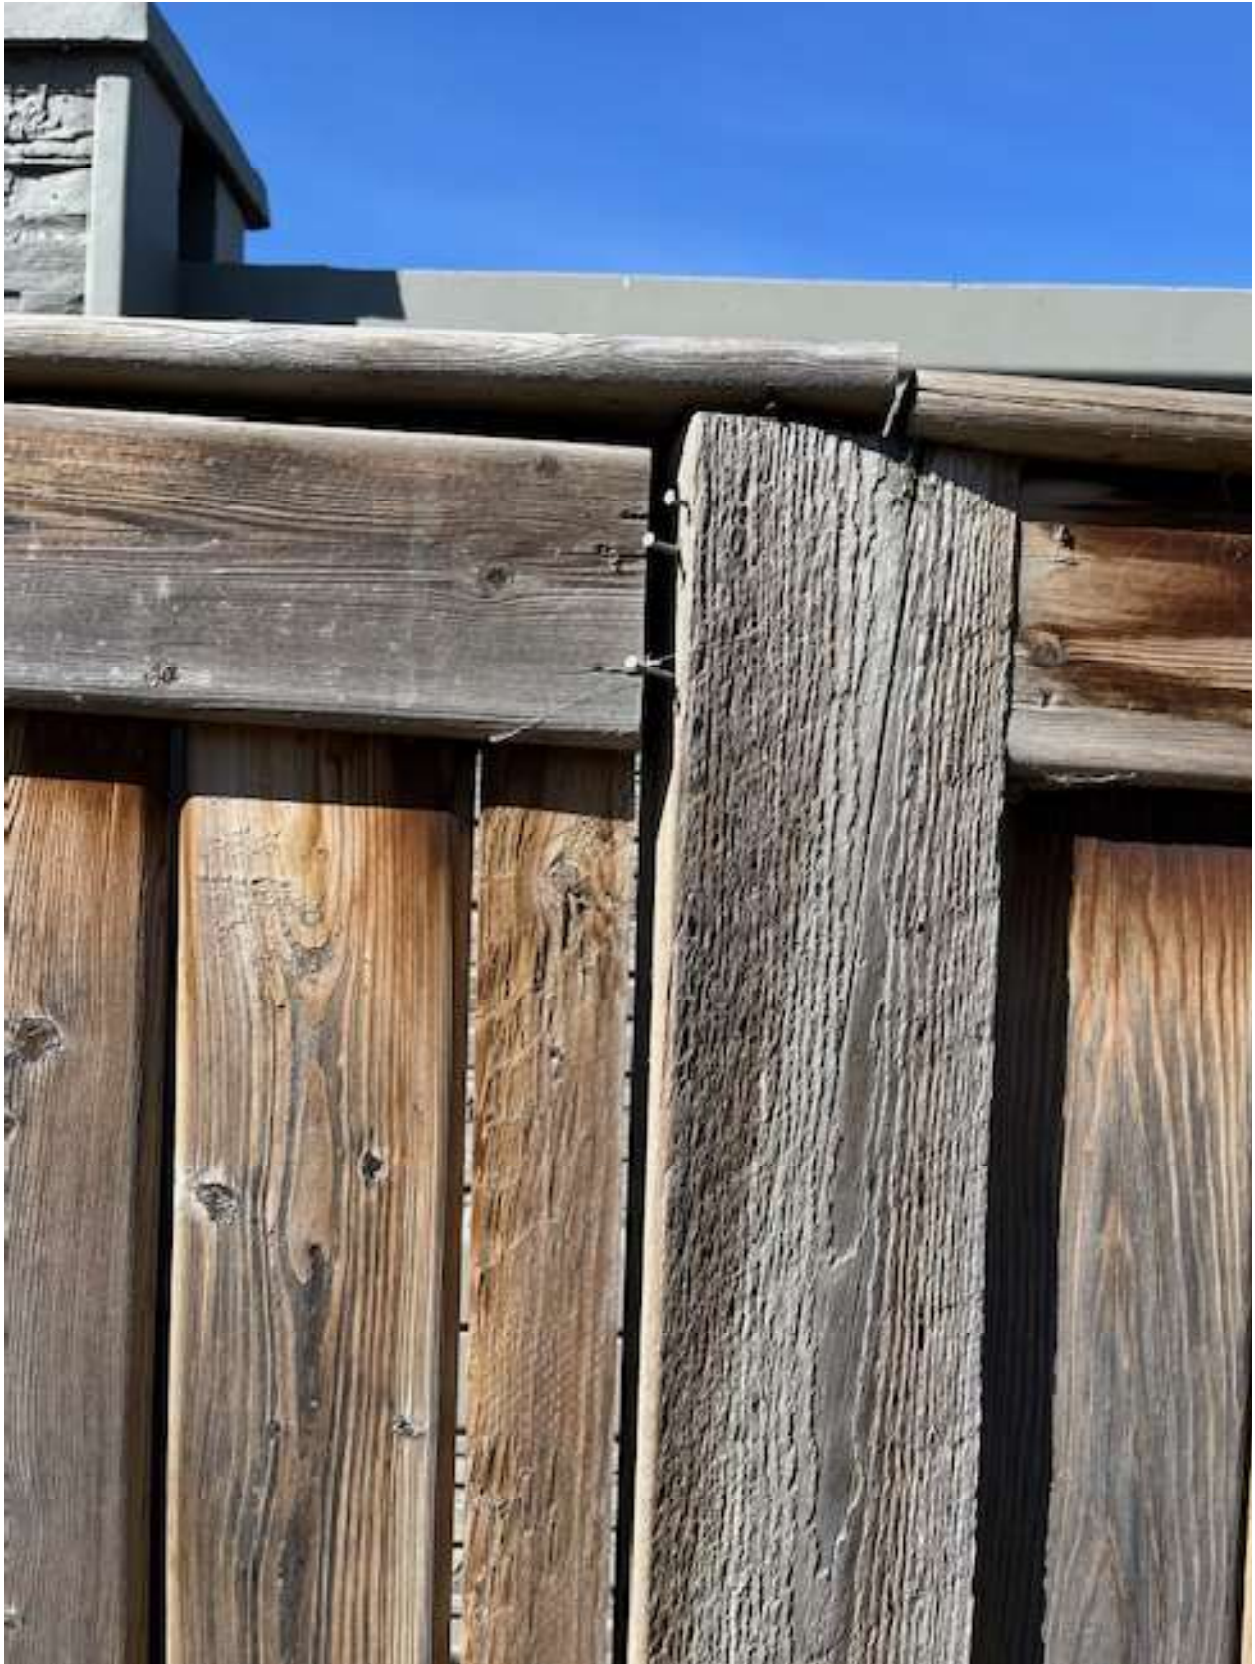
Figure 26 West perimeter fence indicated a twisted post resulting in some pull away of the top rail.
