Bridle Estates Home Owners' Association
Fence Inspection
And
Maintenance Recommendations
April 14, 2025

April 14, 2025
Barry Manovich
Max Lewin
Randy Parsons
Bruce Sorge
Dwayne Thomas
Byron Turner

Summary

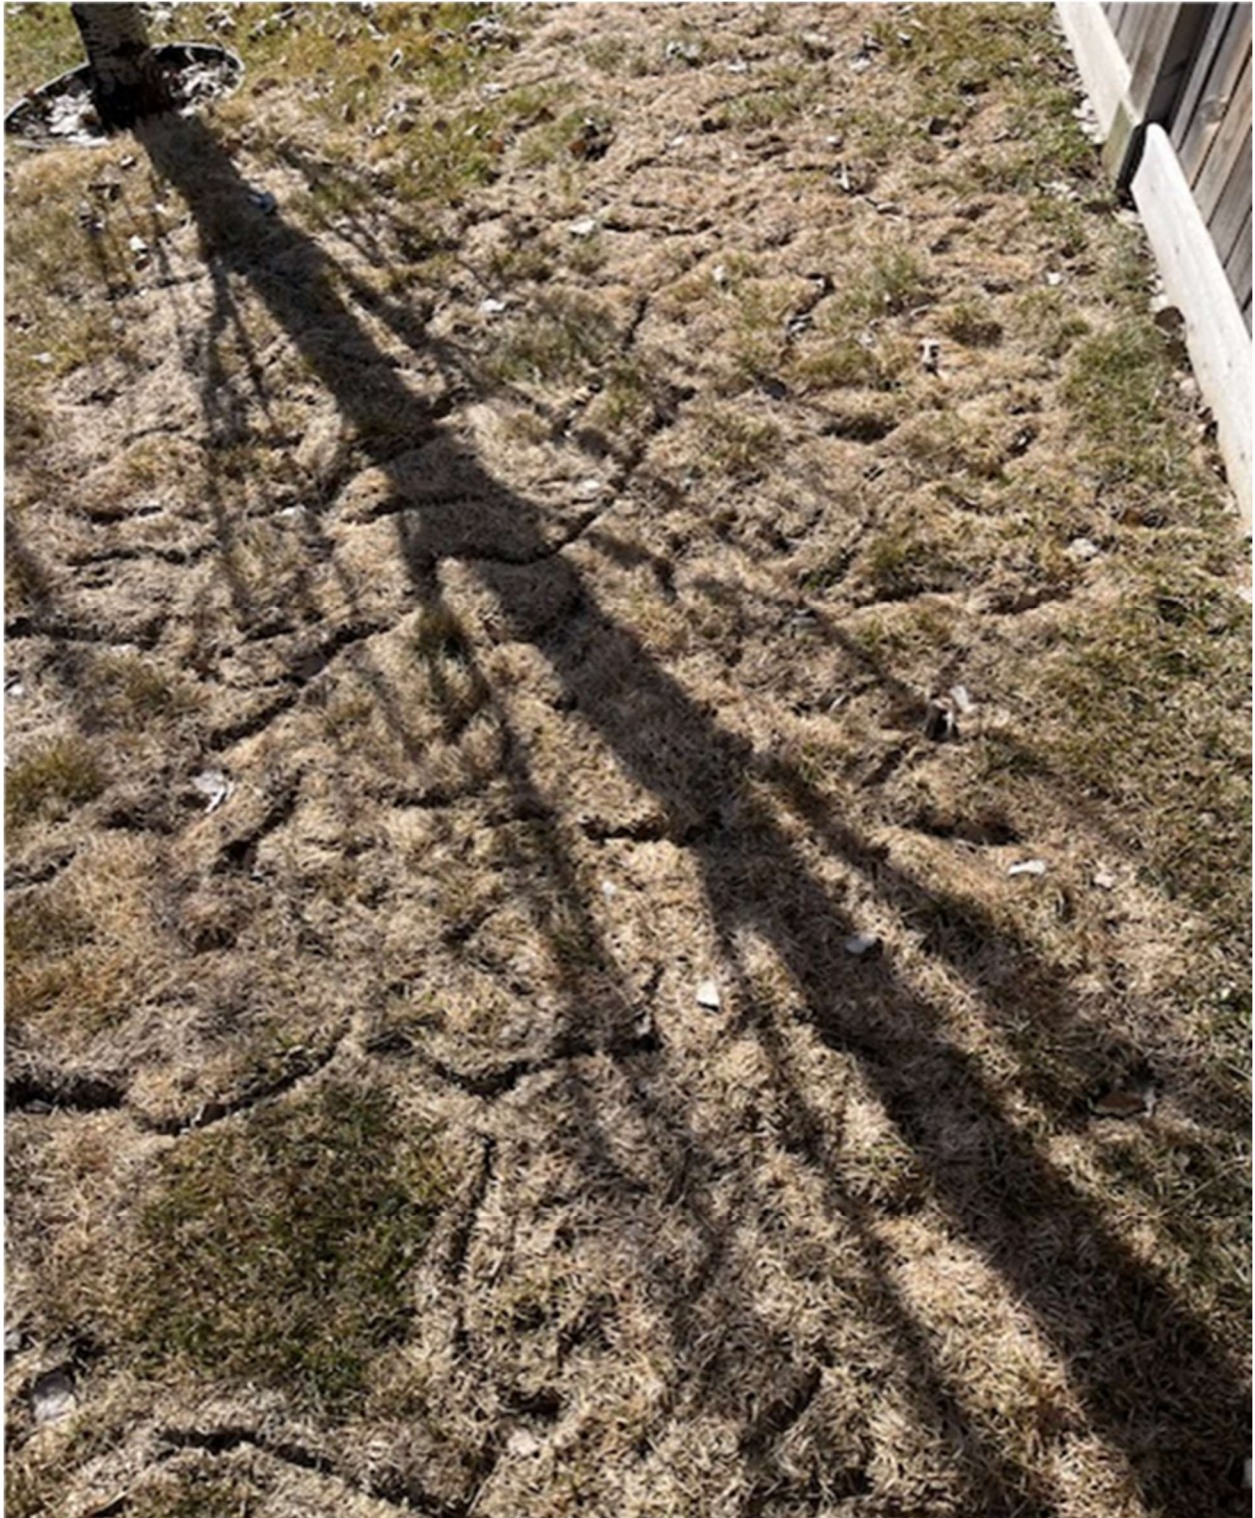
- One sizable area of Vole activity was noted at 129 Bridle Estates Road.
- There are only minor occurrences of material piled against the fence along this section.

Figure 27 Vole activity at 129 Bridle Estates Rd

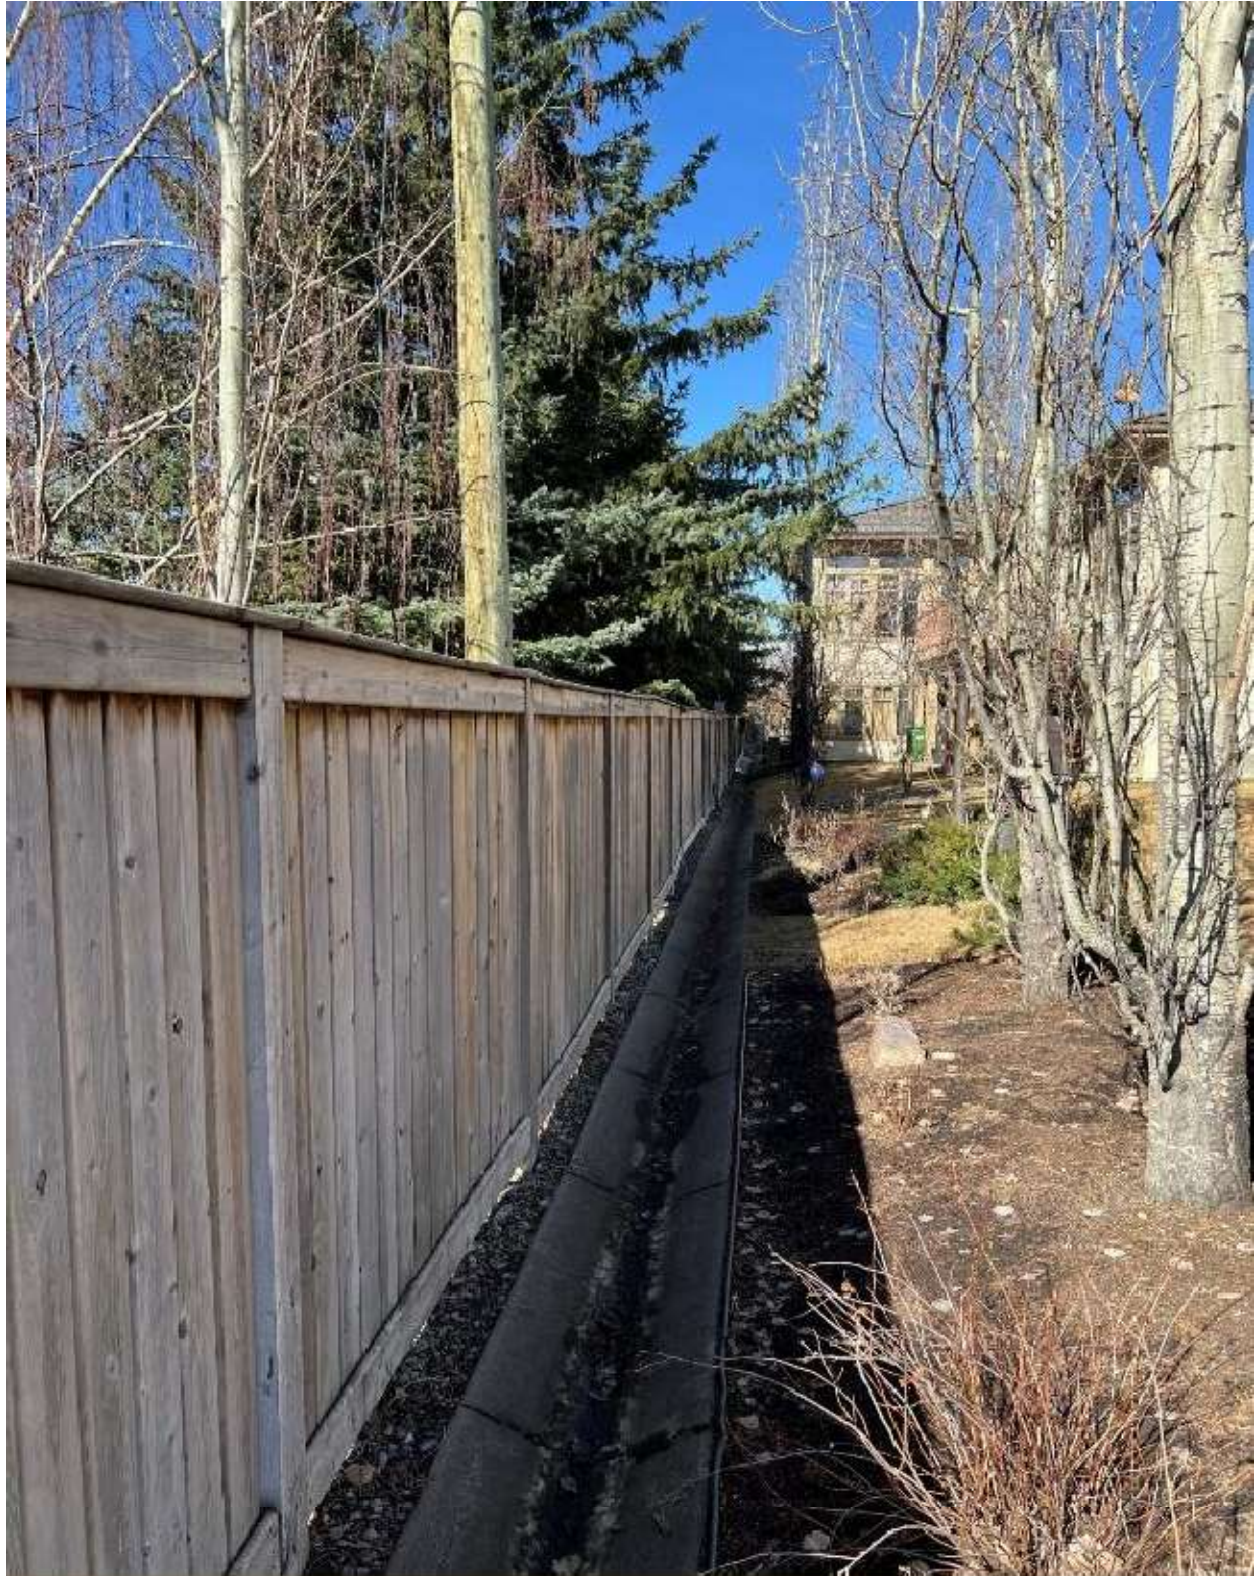
Figure 28 South perimeter fence: rustic patina and fence components requiring no maintenance.

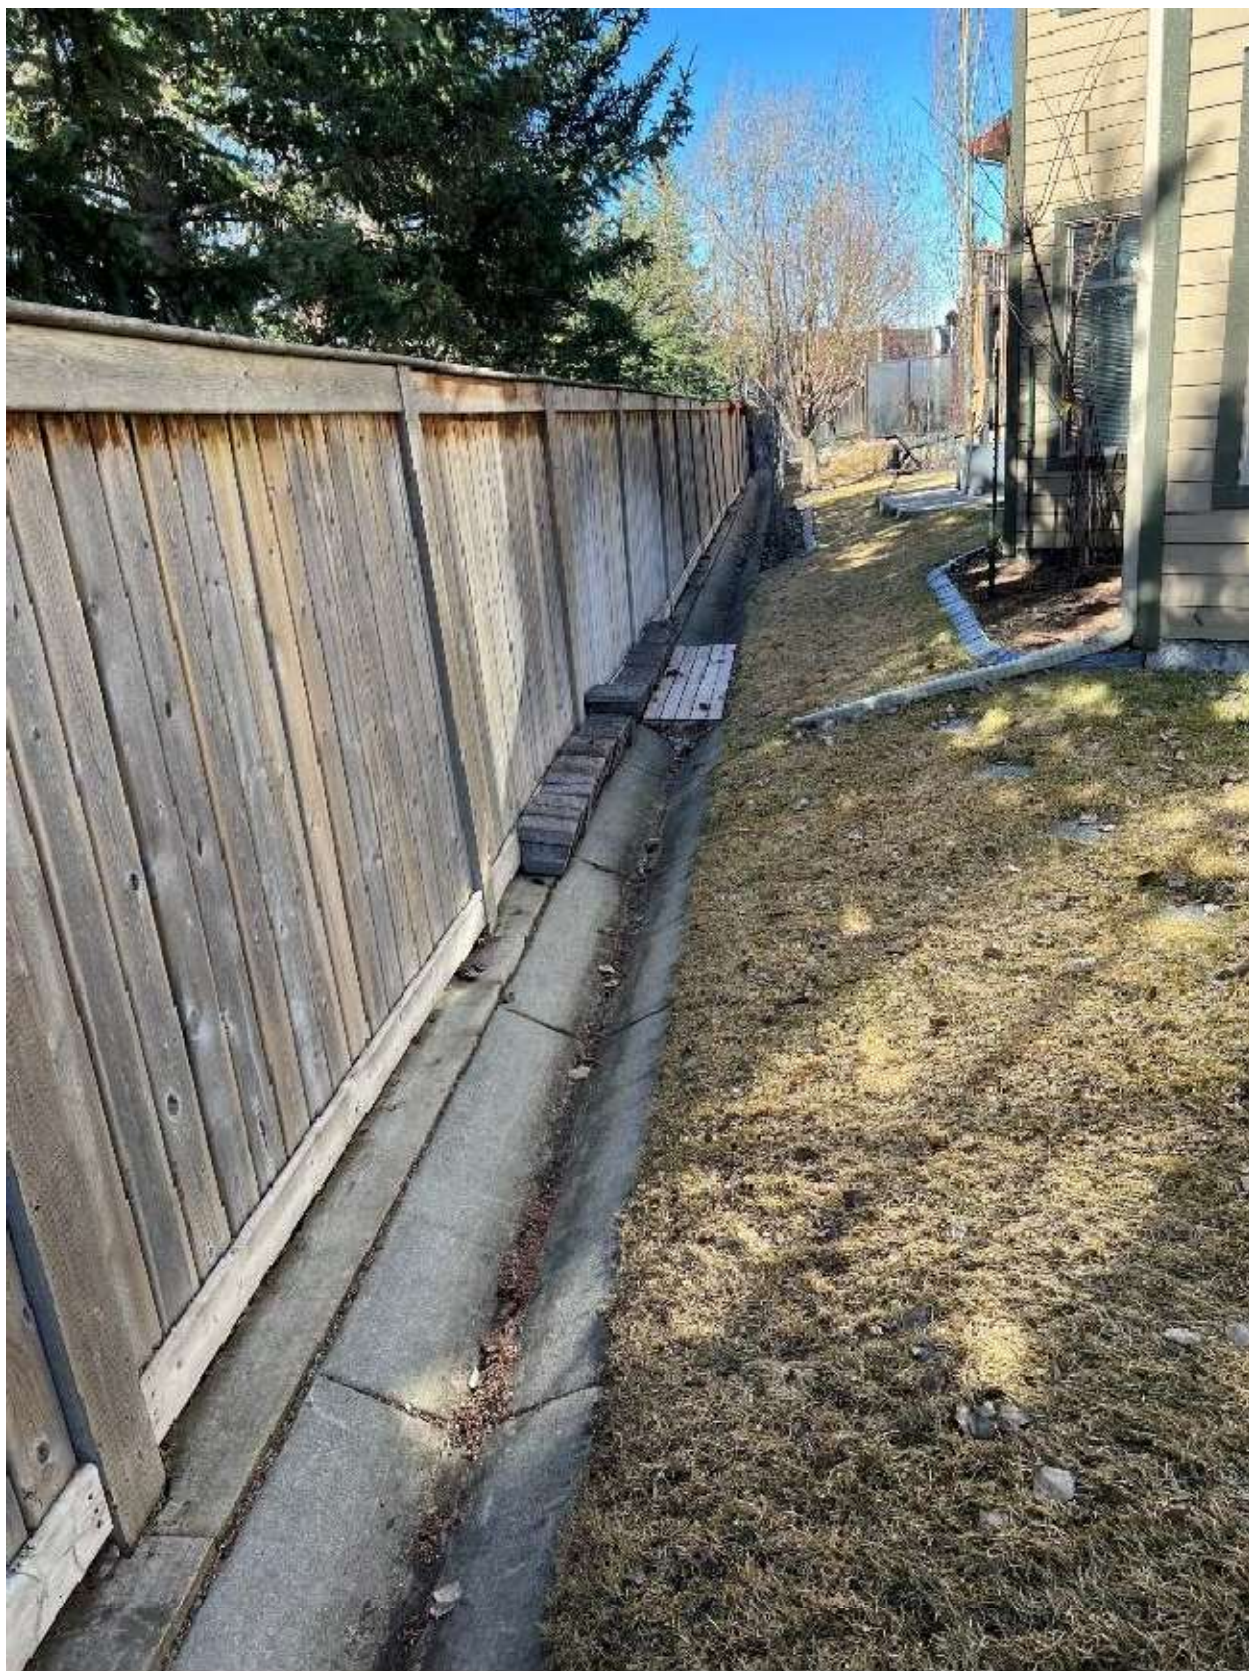
Figure 29 South perimeter fence; the material is not blocking water flow and the owner has agreed to remove the material

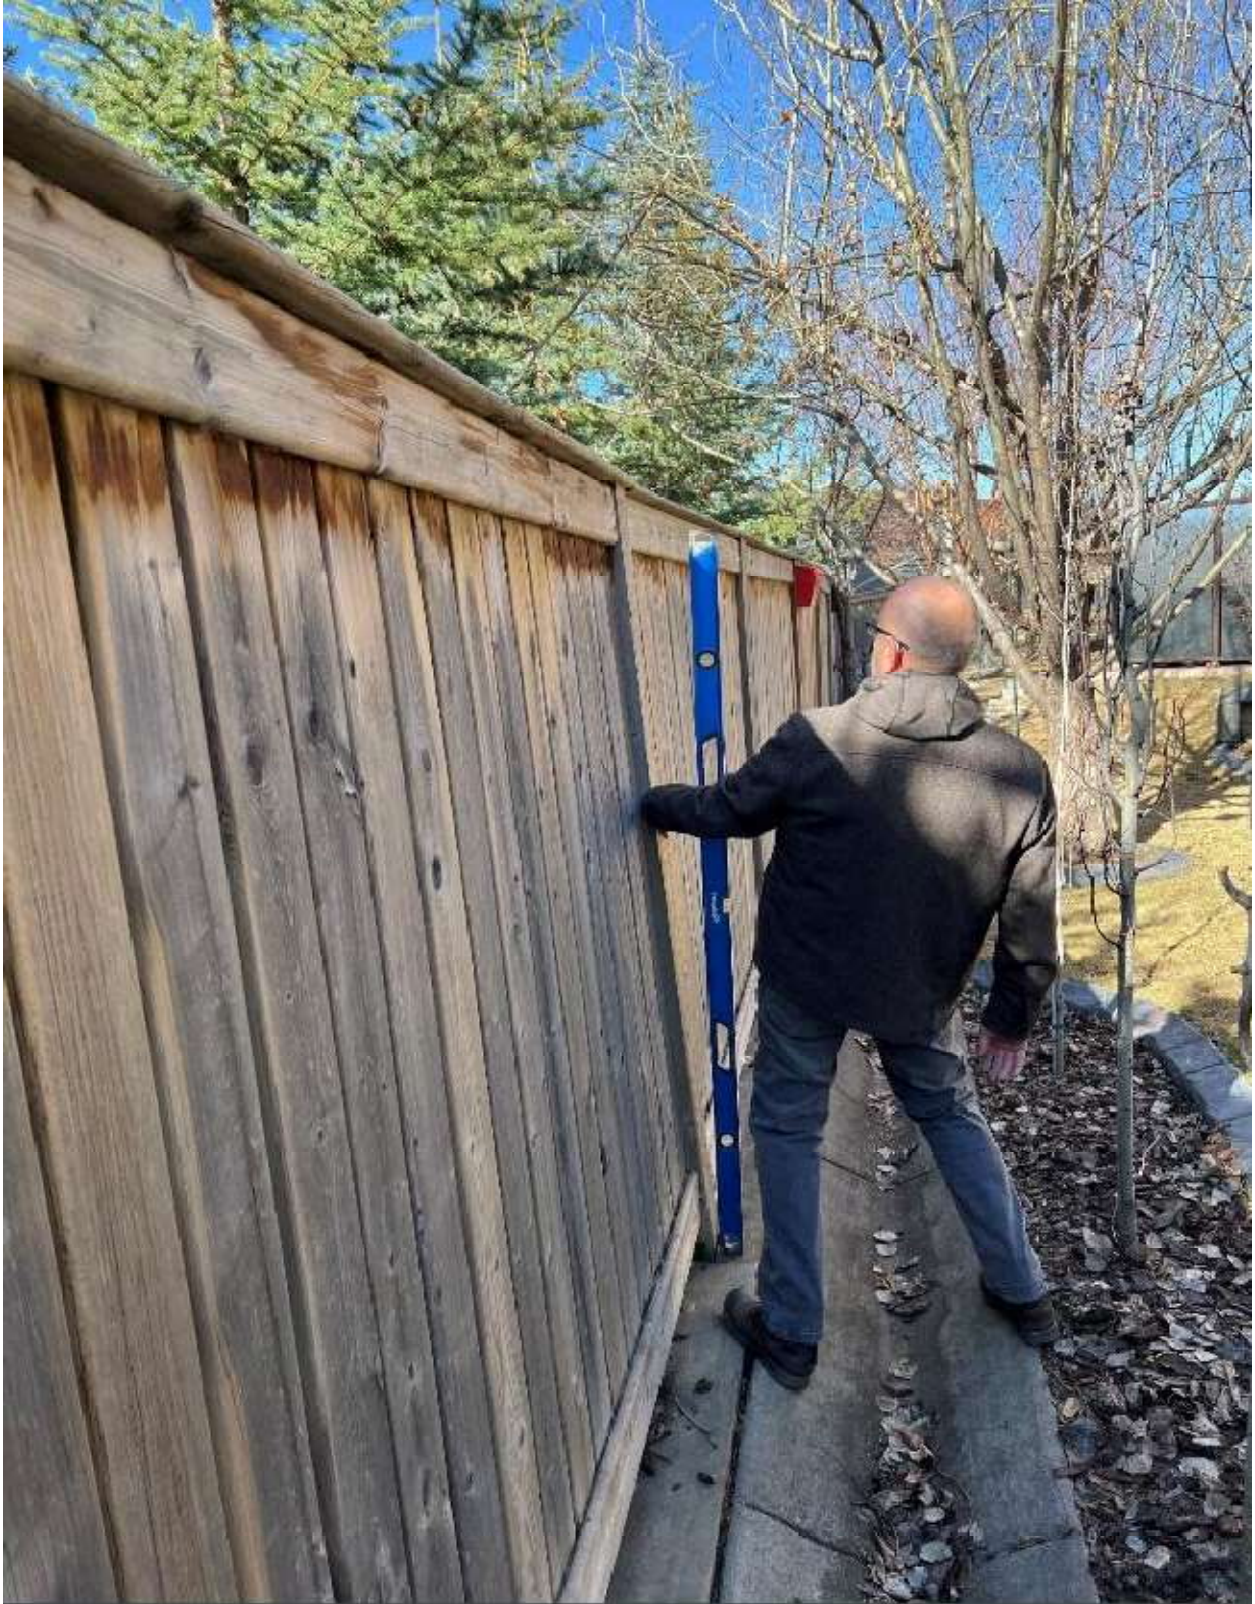
- This fence is in good repair and matches that of the west perimeter fence.
- There is some bowing in the fence, leaning north into Bridle Estates.
- The posts are imbedded in concrete which would make straightening the fence a difficult task.

Figure 30 the south perimeter fence showing the lean to the south. The posts are embedded in concrete rendering the fix to vertical a relatively expensive task.

1. The recommendation at this time is to do nothing to this section.

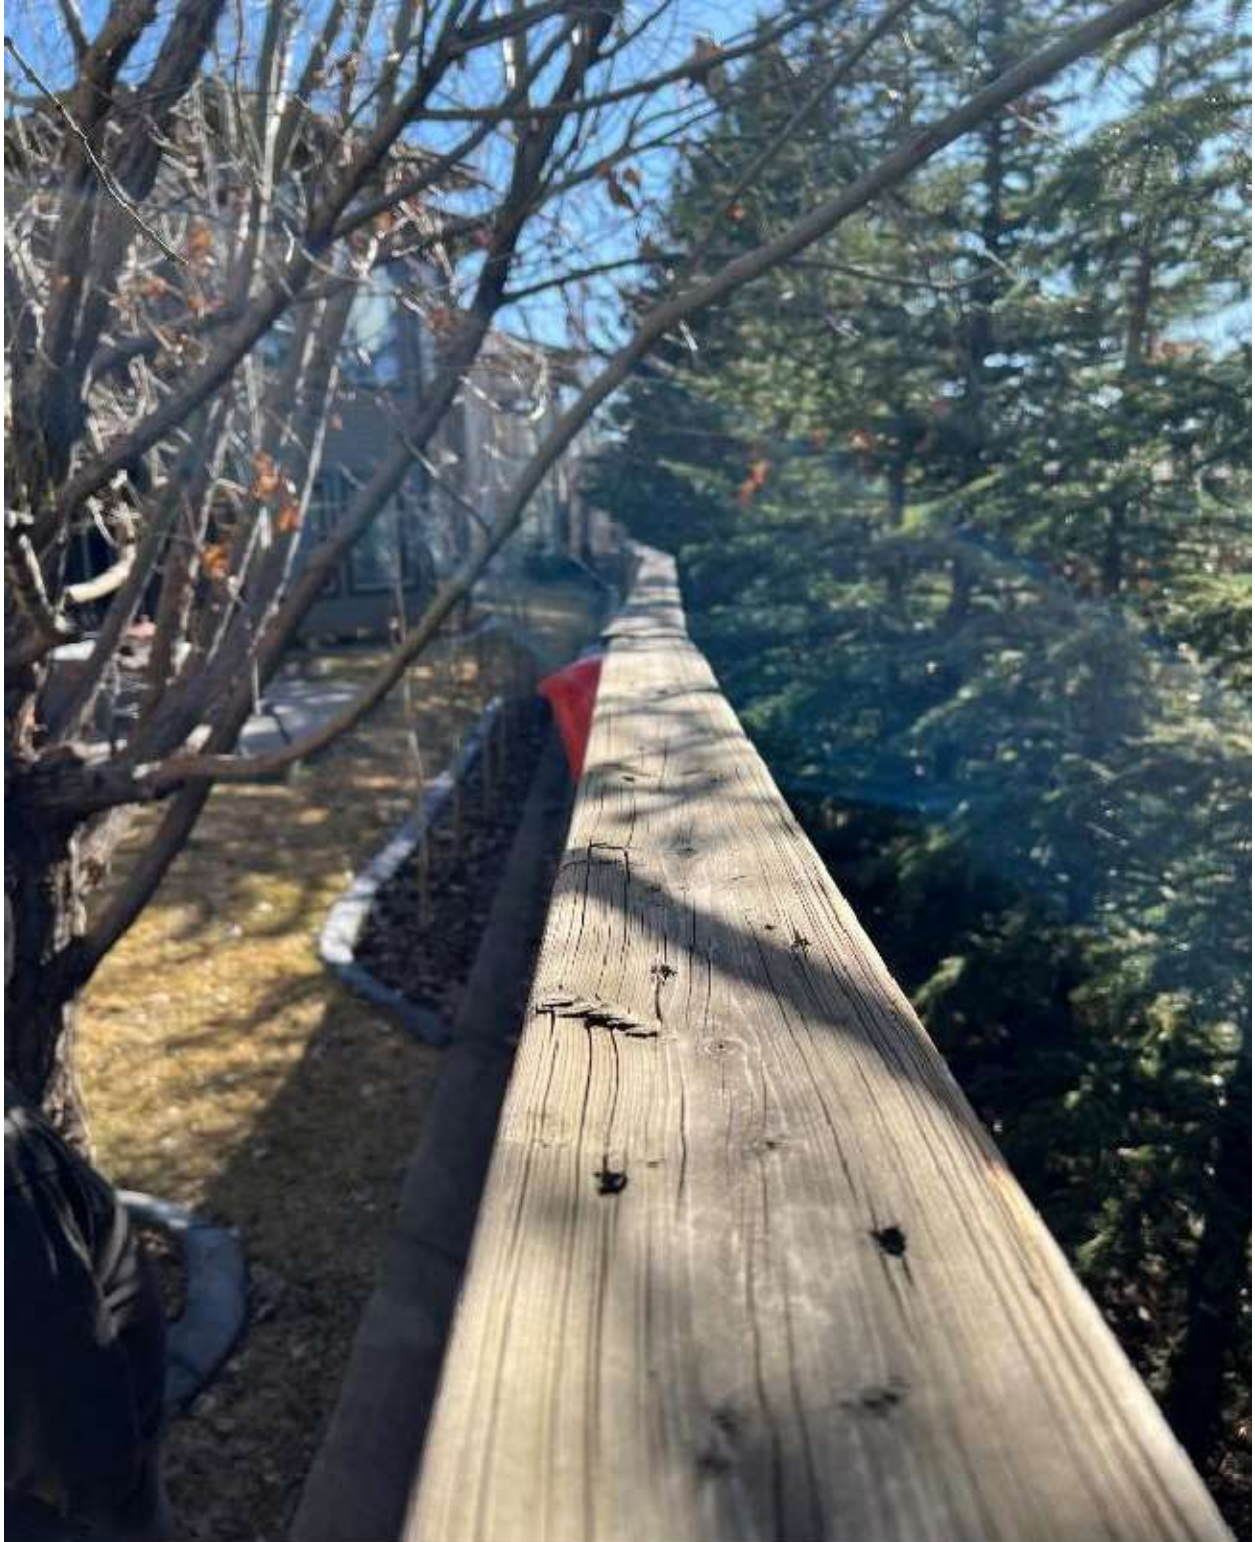
Figure 31 South perimeter fence indicating a top plate in good condition and the non-bow to the south.

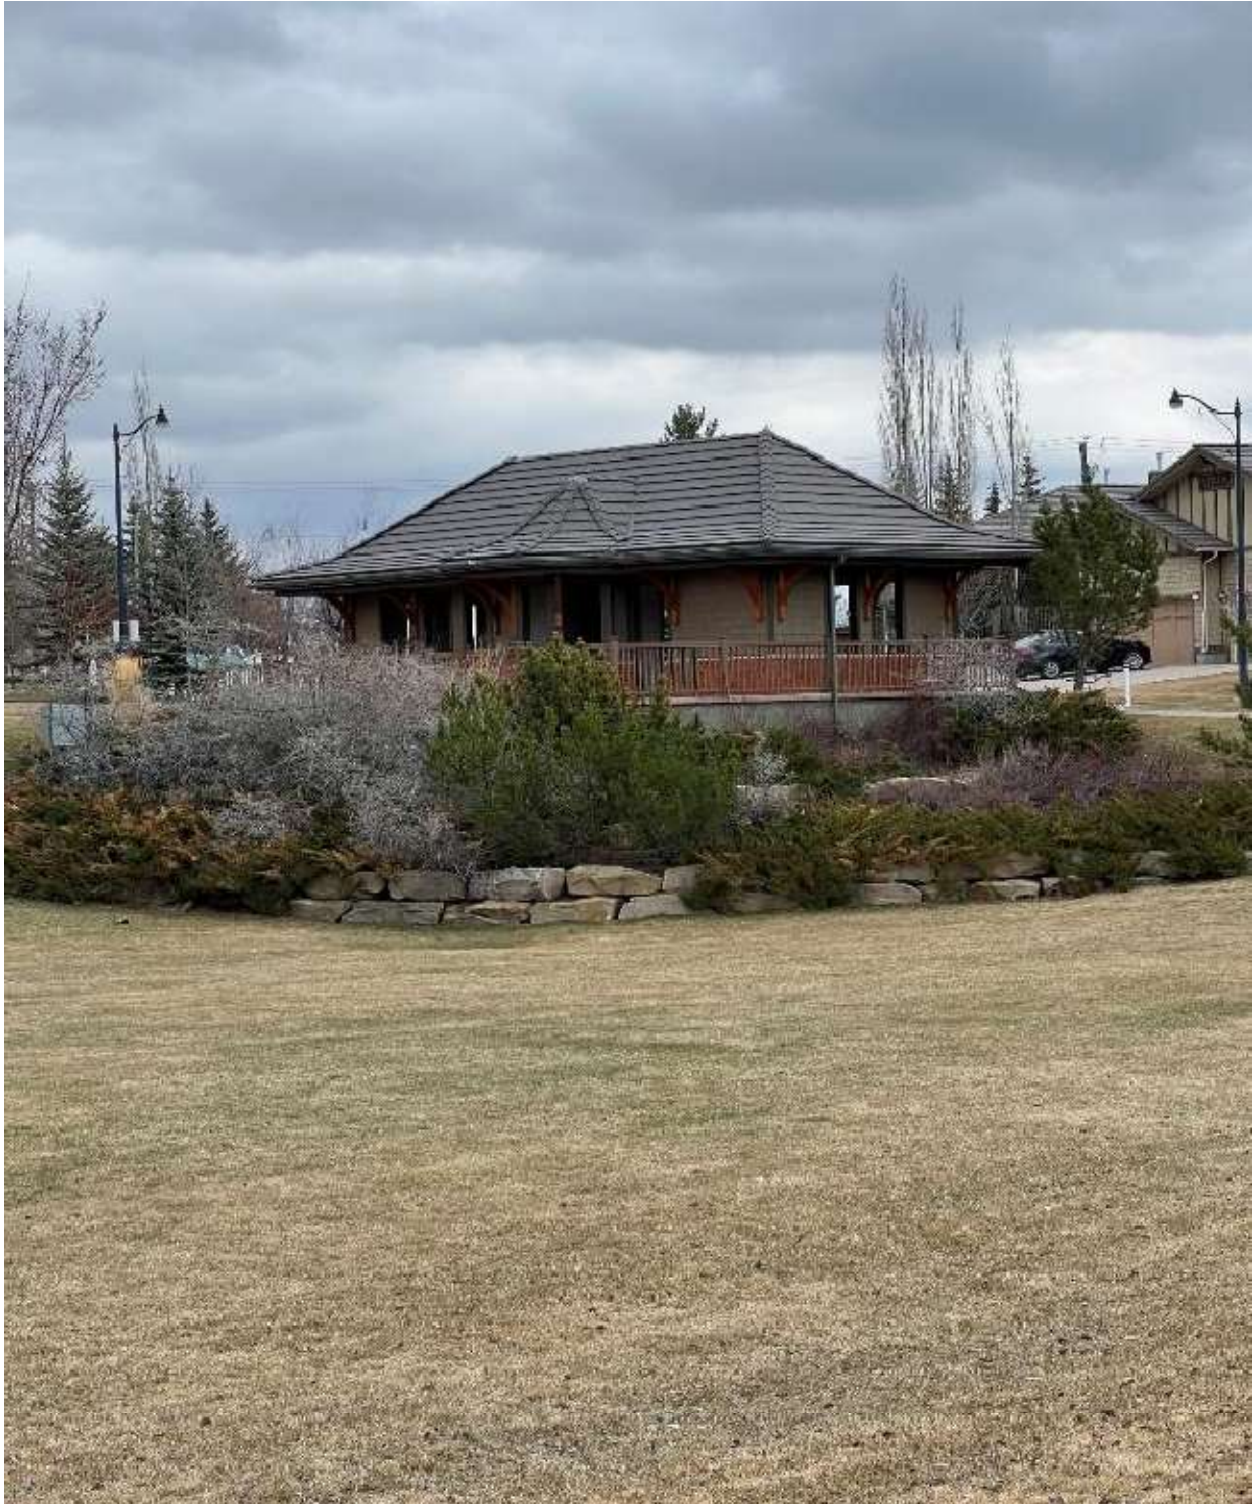
Figure 32 General view of the Pavilion, no exterior maintenance identified

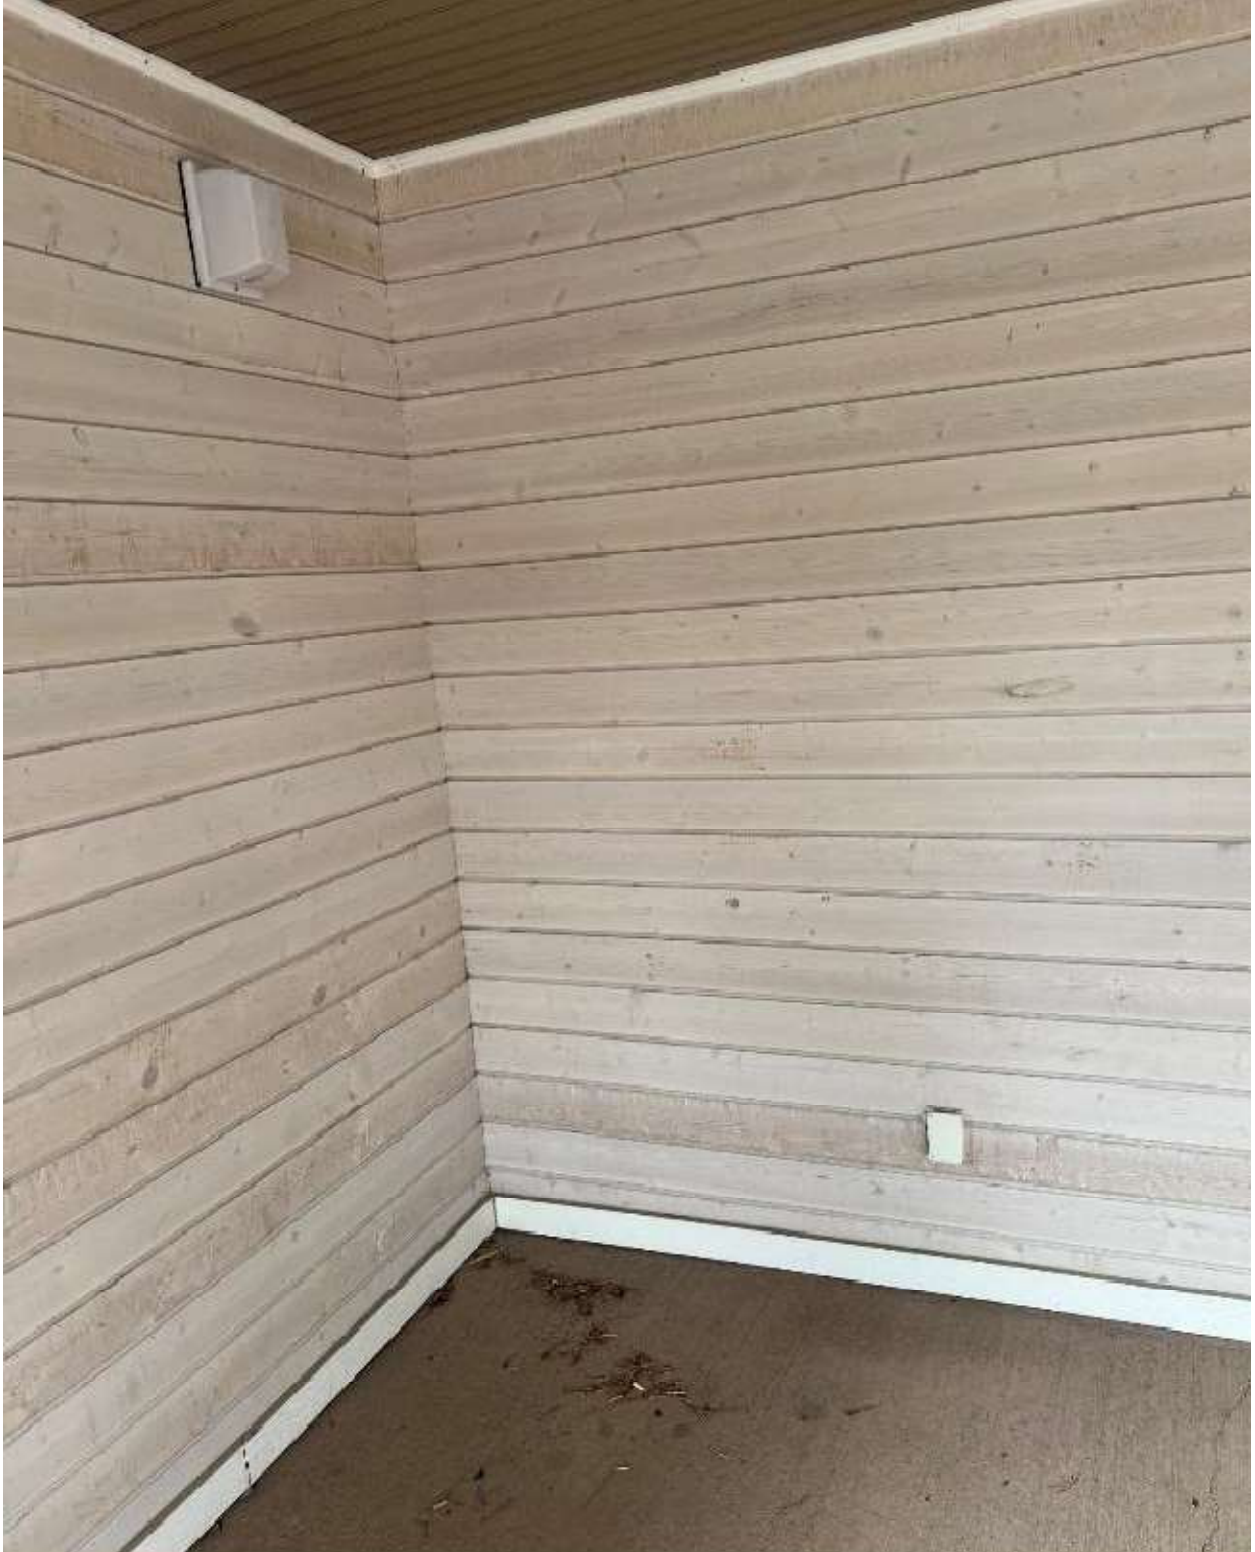
Figure 33 Interior wall of the pavilion indicating the white washed-stained walls.

1. The interior walls should have a coating of white wash ~~stain~~ applied if for no other reason than to inform non resident users that the facility is well maintained and any visitors should demonstrate a respect for the standard of up keep.

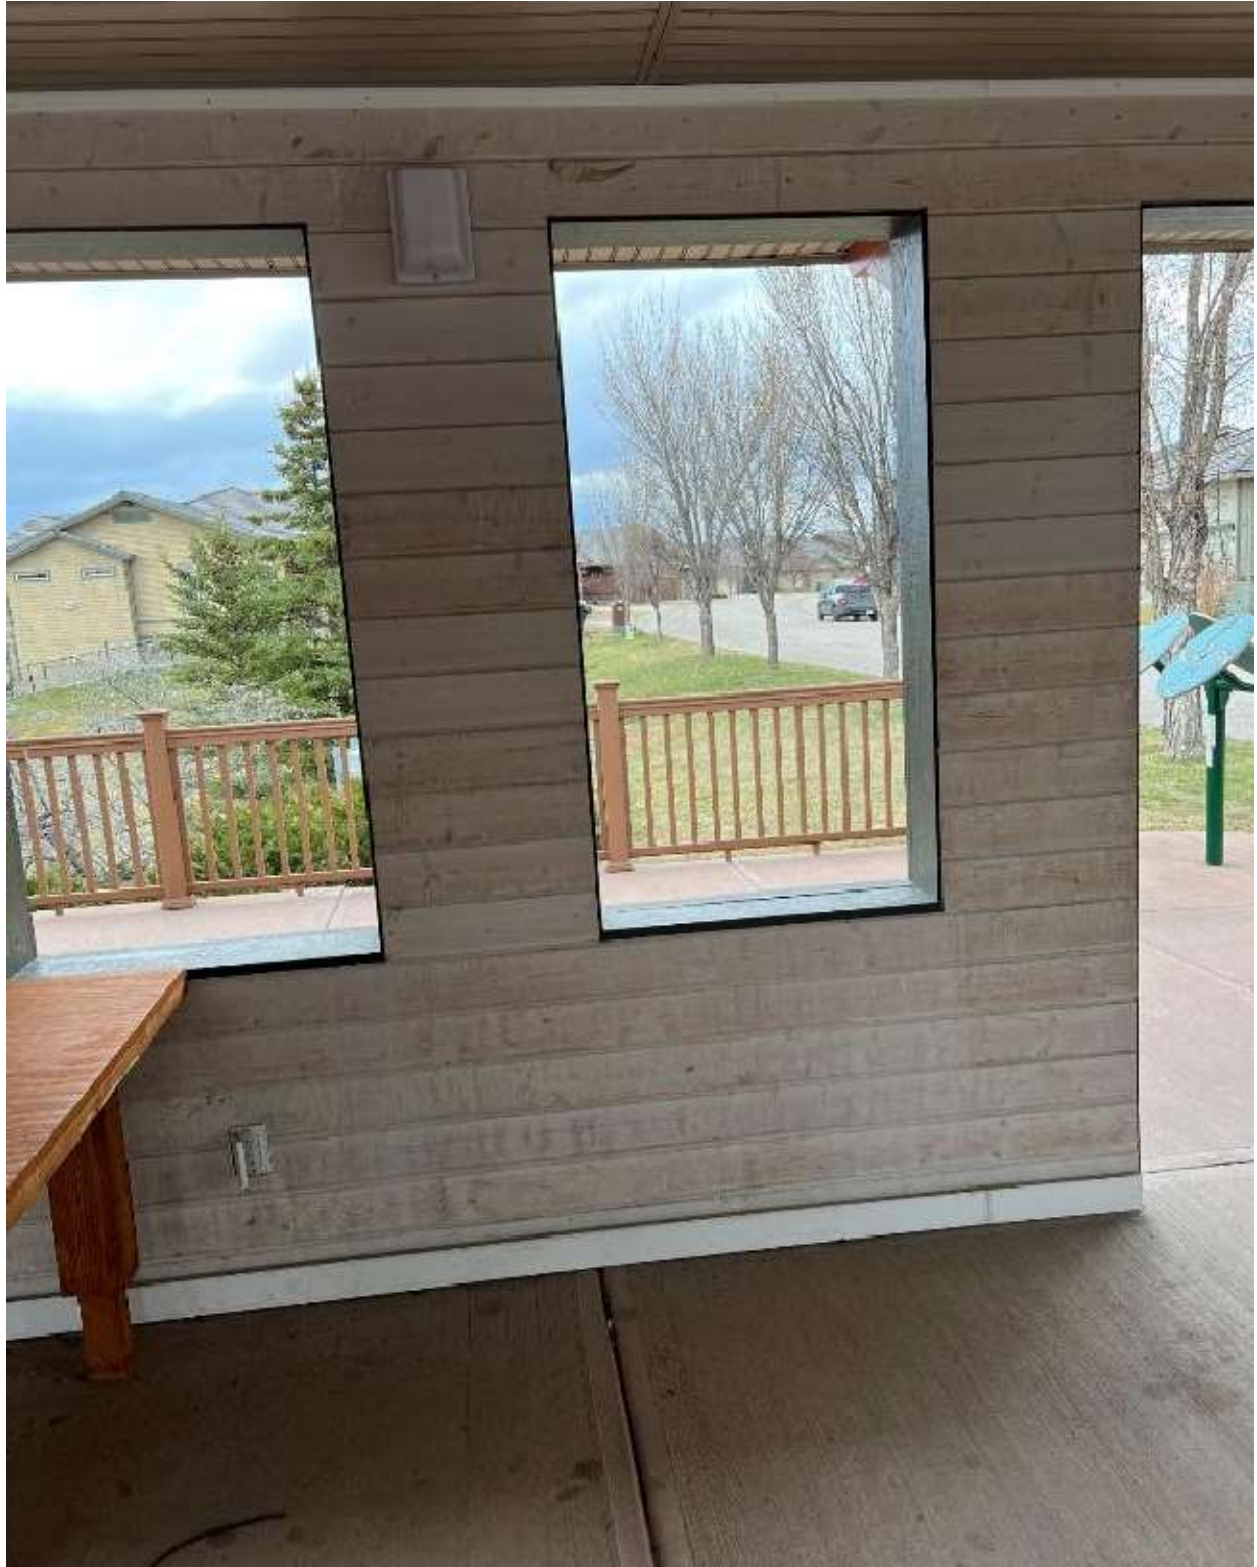
- A walk around the exterior revealed no issues.
- The interior walls are white washed wood material. The walls have scuff marks.
- The exterior of the pavilion was painted in 2023 including the railing.

Figure 34 Interior of the pavilion indicating the scuff marks on the wall.
