Bridle Estates Home Owners' Association
Fence Inspection
And
Maintenance Recommendations
April 14, 2025

April 14, 2025
Barry Manovich
Max Lewin
Randy Parsons
Bruce Sorge
Dwayne Thomas
Byron Turner

Summary

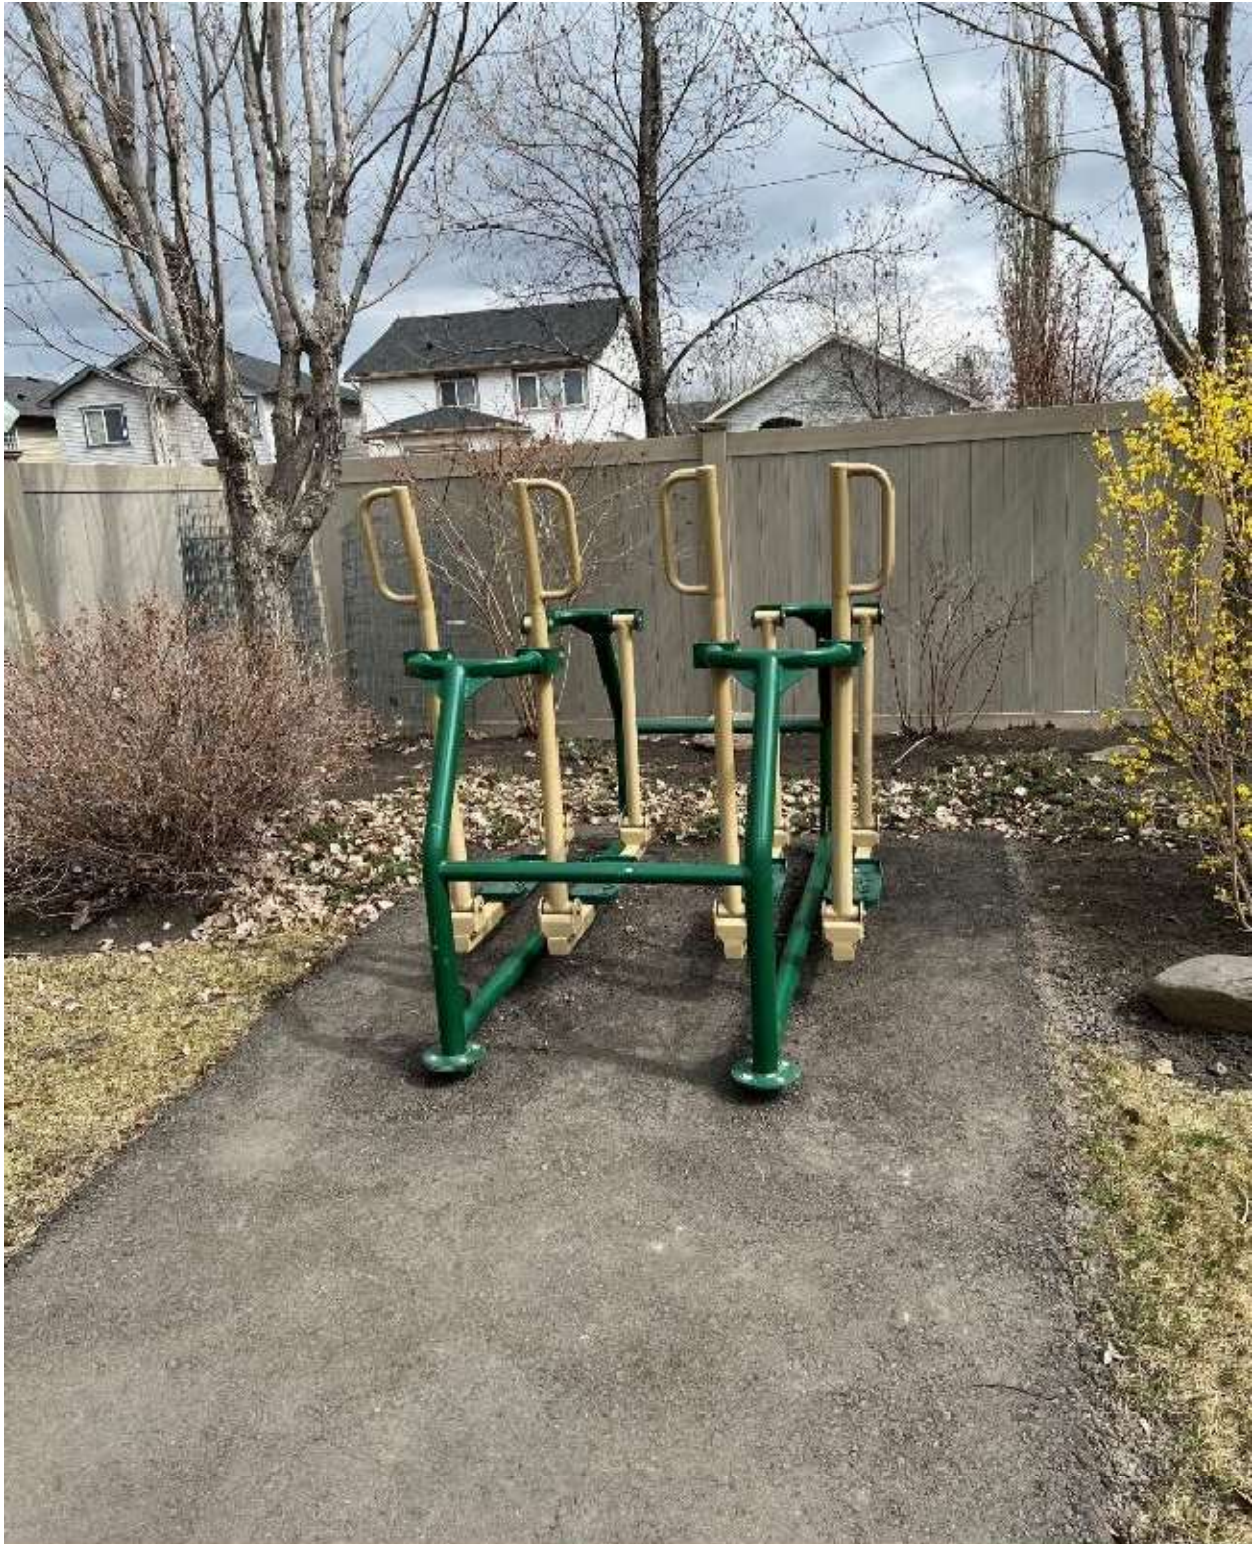
- These machines are maintenance free.
- No deficiencies were identified other than very minor signs of rust in a few locations
- Several users were interviewed and no issues with use were identified.
- In the past several holes were drilled in low spot components to drain any water accumulation.

Figure 35 Dual glider exercise machine in the linear park

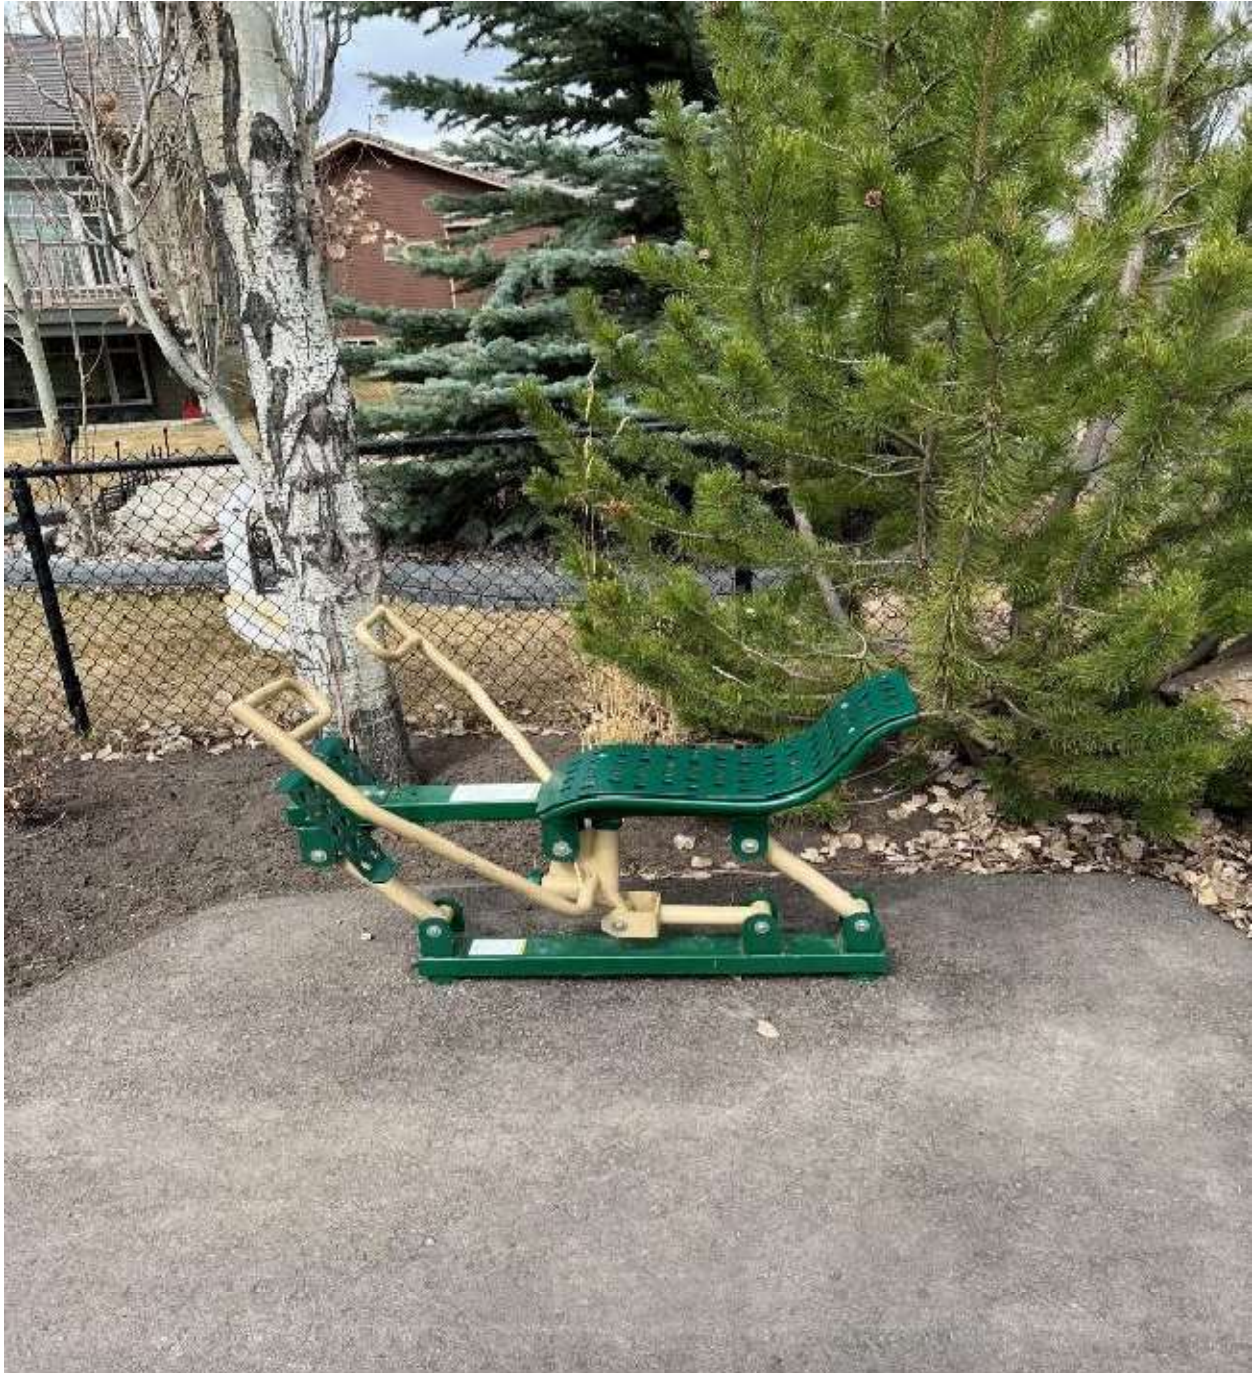
*Figure 36 Rowing machine in the linear park***Recommendation Exercise Machines**
